# BUILDING SURVEY REPORT

**PROPERTY** Sample Survey  
Anytown  
AA11 1AA

**SURVEY DATE** 2 Jan 2018

**REF** 12345

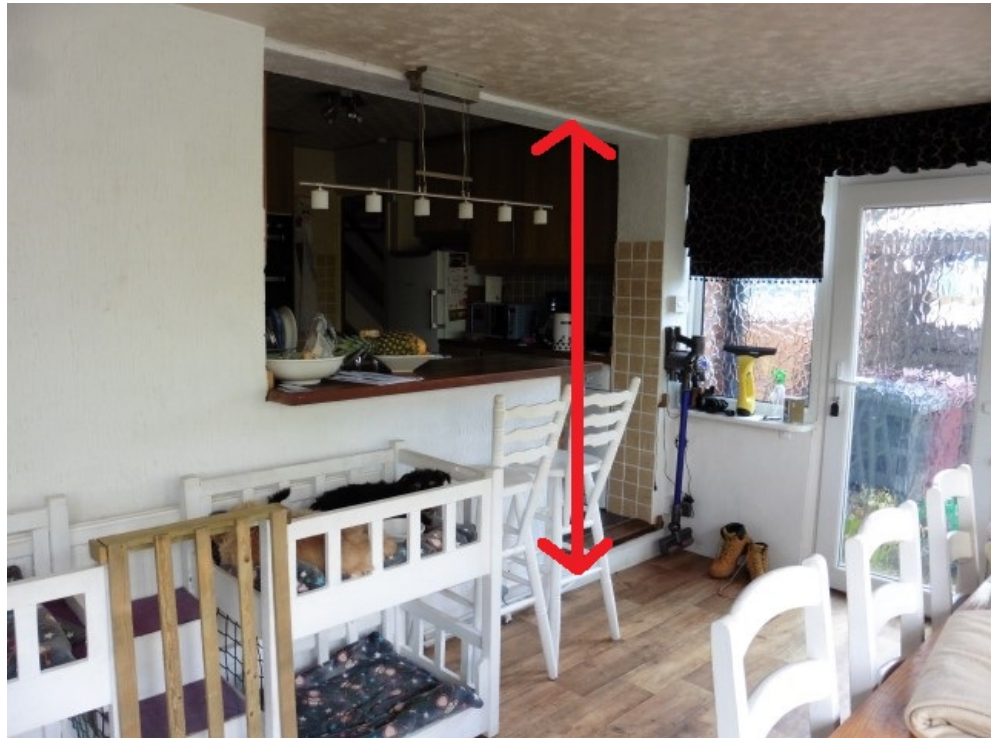
Wall partially removed between the kitchen and sun room

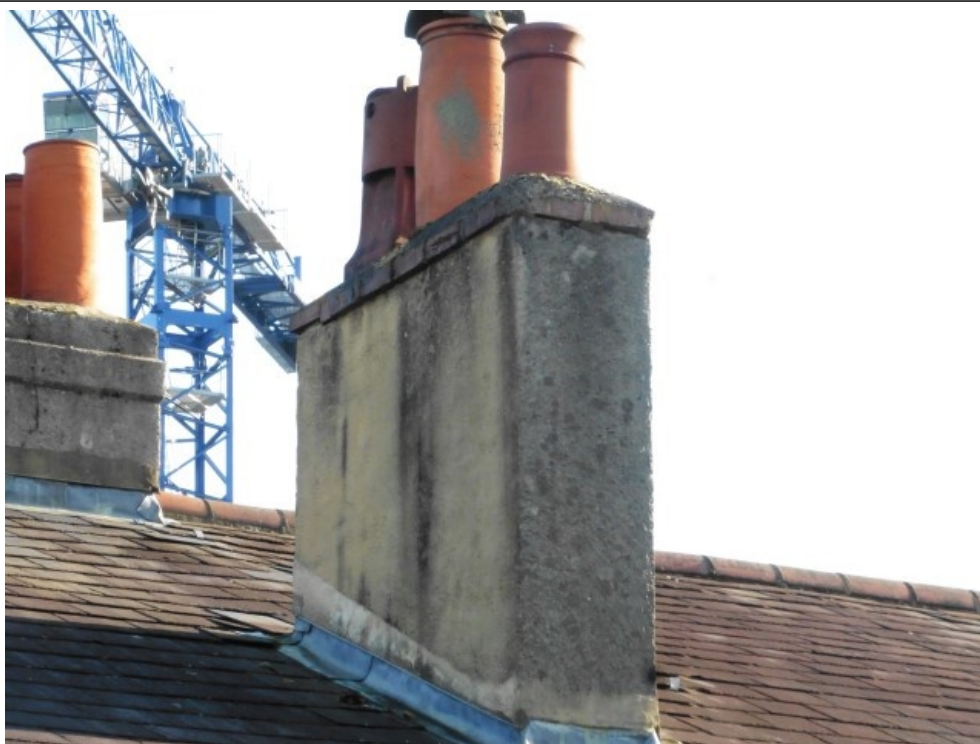
<b>4.1 Chimney Stacks</b>	<b>Condition rating</b>	<b>1</b>
<b>Construction &amp; Type</b>	<p>There are two chimney stacks at the property. Both are built of brick and each has a single outlet. The flashings at the base of the stacks at the junction with the roof slopes are of lead. The stack to the right side originally served a flue to the kitchen and the opening is topped with a metal terminal.</p> <p>The stack to the left side serves of the fireplace in the living room and the opening is topped with a clay cowl. There is a television aerial attached to this stack.</p>		
<b>Nature of inspection and Limitations</b>	<p>The chimney stacks were examined from ground level with the aid of binoculars for possible defects including undue movement, distortion, chemical or weather related damage, brickwork, render and pointing damage and other evidence of failure.</p>		
<b>Condition</b>	<p>No significant defects were noted and the chimney stacks were found to be structurally stable. No evidence was seen of any unusual cracking or other failure, or of unusual wear of the bricks or mortar pointing between the bricks.</p> <p>The flashings at the base of the stacks are, as far as can be seen, in a serviceable condition.</p>

Rear stack viewed from the rear

<b>Action Required</b>	<p>The chimney stacks should be regularly monitored for any indications of damage, instability or other defects. You should carry out a thorough visual inspection at least once a year, ideally in the Spring, and ideally at roof level, to identify and repair any damage that could have been caused by winter weather.</p> <p>Missing, loose or defective mortar should be repointed as necessary.</p> <p>It is advisable to fit cowls on the top of the pots of any open flues.</p>

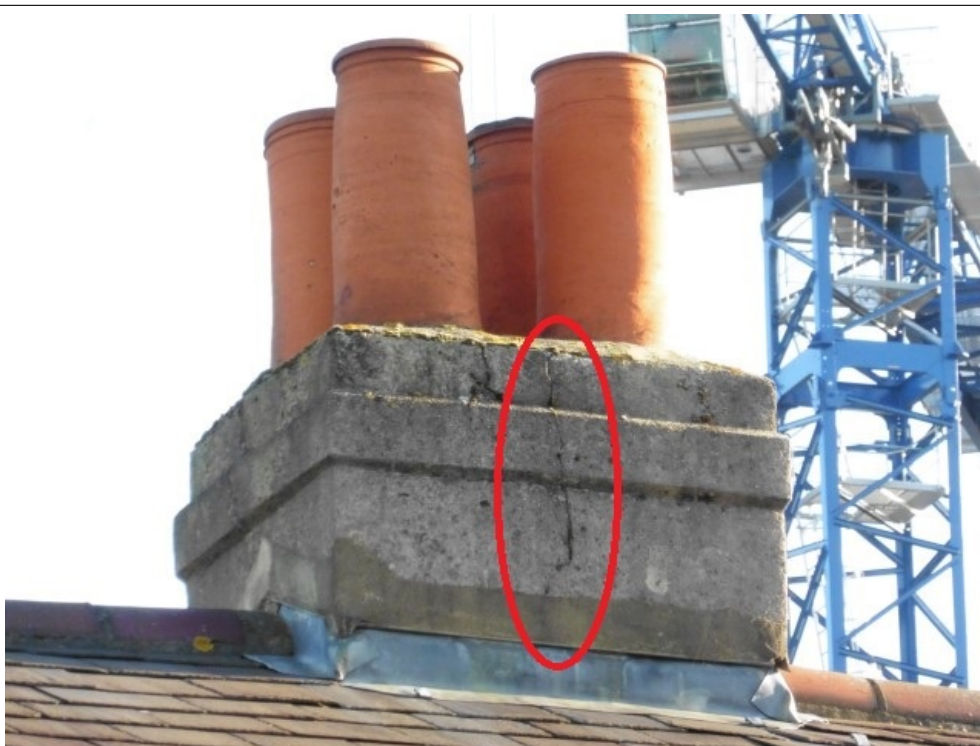
Central stack viewed from the front

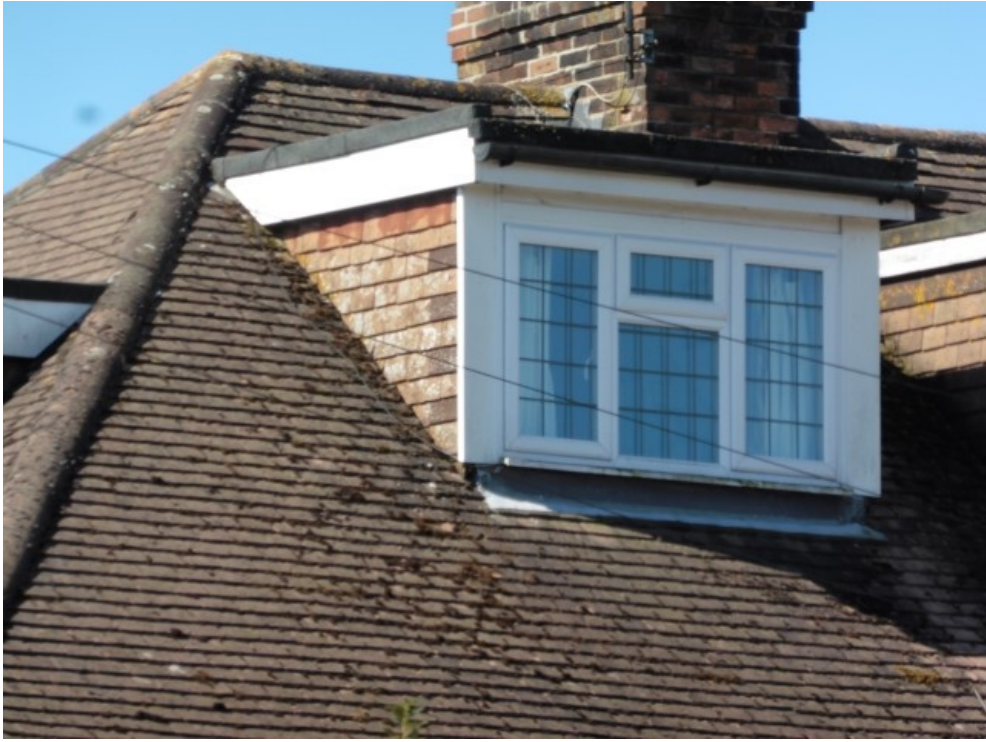
<b>4.2 Roof Coverings</b>	<b>Condition rating</b>	<b>1</b>
<b>Construction &amp; Type</b>	The roof is formed from a single ridge running across the width of the property, with pitches to the front and rear and with a hip to the left side. The main roof pitches are covered with interlocking concrete tiles. The roofs of the front and rear dormers and the sun room extension are flat and covered with bituminised (also known as “torched”) felt.		
<b>Nature of inspection and Limitations</b>	The roof was examined from ground level with the aid of binoculars where necessary for possible defects including sagging, collapse, broken/missing/damaged tiles, holes, and other evidence of failure.		
<b>Condition</b>	No significant defects were noted and the main roof was found to be structurally stable. No evidence was seen of unusual sagging or other movement which might indicate that the structure is failing. No evidence was seen of any unusual amounts of moss growth, or of slipped, chipped or cracked tiles.

<p style="text-align: center;">Front roof and dormer</p>

<b>Action Required</b>	Carry out normal maintenance including removal of moss build-up. Any slipped, missing or broken tiles on the roof pitches should be repaired and replaced. You should carry out a thorough visual inspection at least once a year, ideally in the Spring to identify and repair any damage that could have been caused by winter weather.

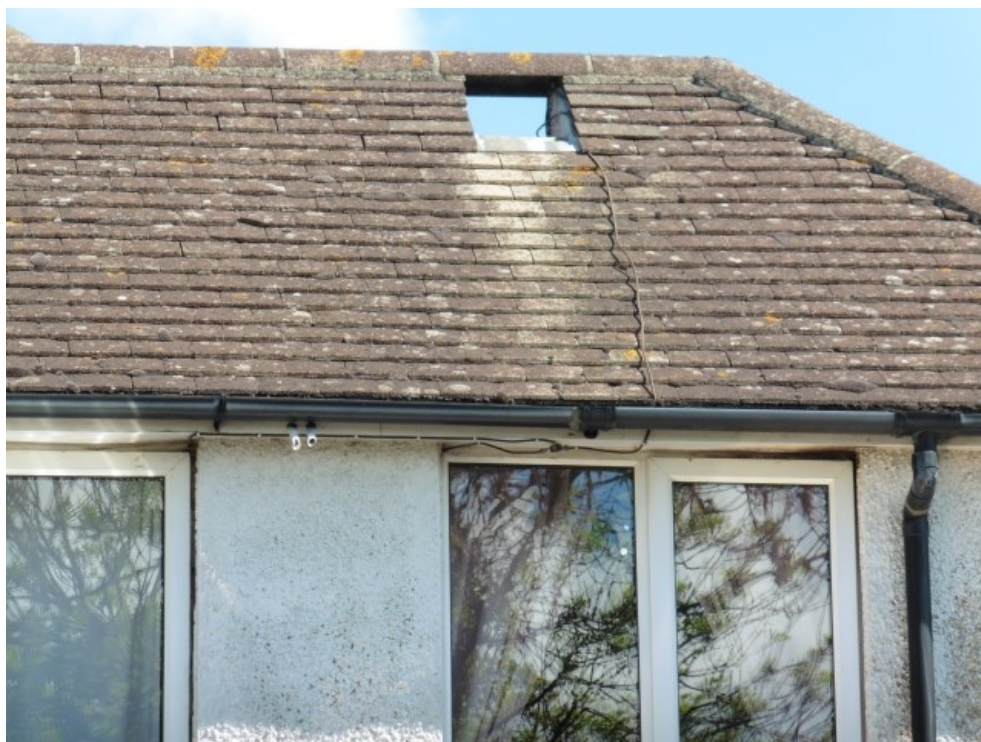
Rear roof pitch

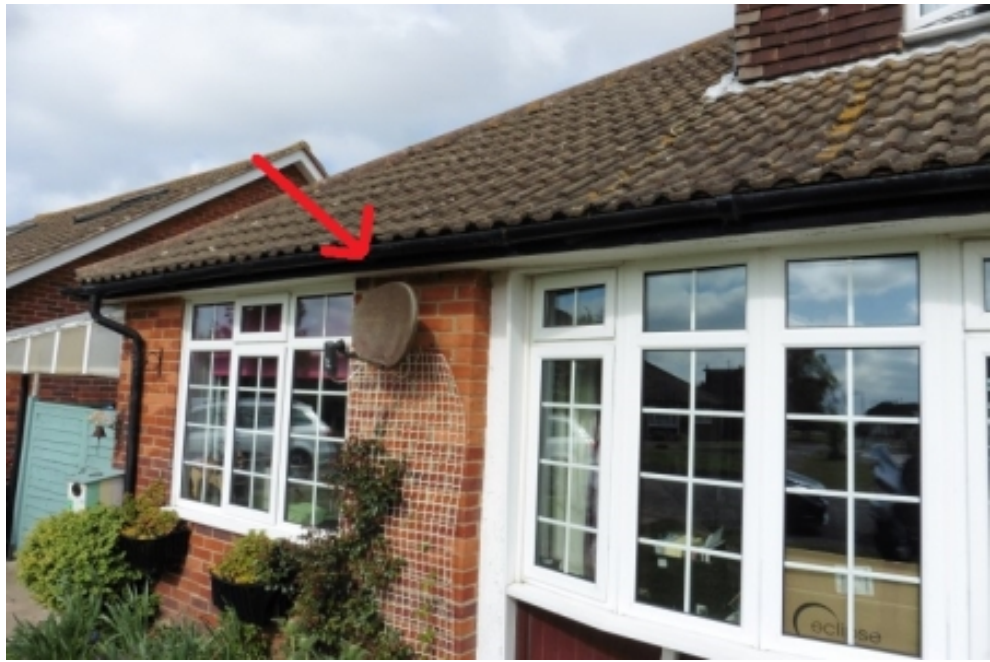
Sagging gutter at the front

<b>Action Required</b>	The gutter at the front should be repositioned to ensure that it is not sagging or leaking. This is not considered to be work of an urgent or major nature, but should be carried out as soon as possible to prevent further damage to the building.  Gutters and downpipes should be cleaned and inspected .....

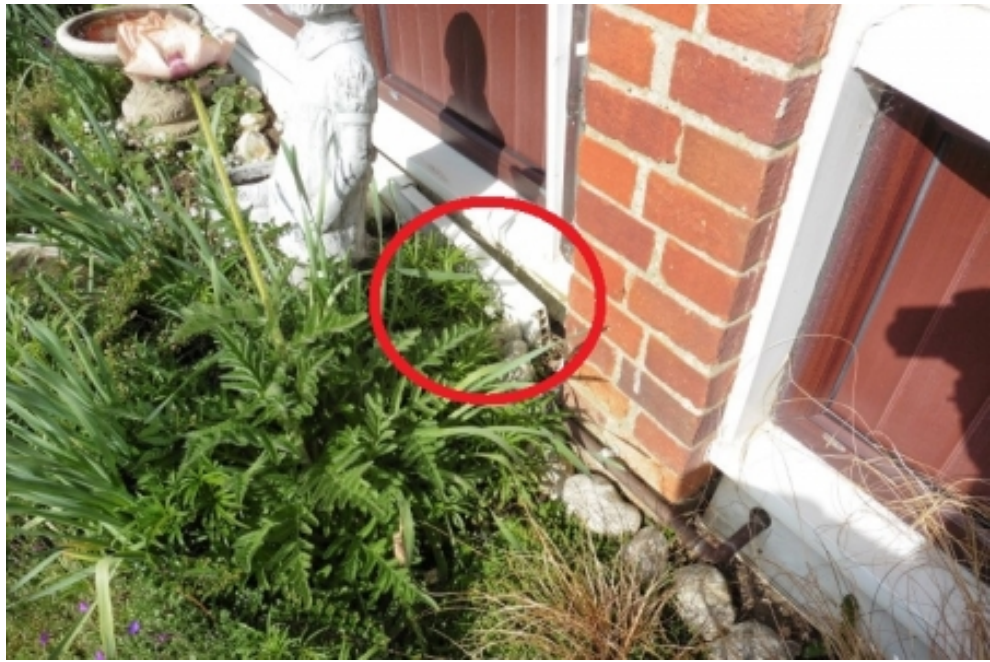
Loose plastic trim at the front

<b>Action Required</b>	<p>Walls should be examined regularly to inspect for changes in the nature of any cracking or other defects that may become apparent.</p> <p>You should carry out a thorough visual inspection at least once a year, ideally in the Spring to identify and repair any damage that could have been caused by winter weather.</p> <p>The plastic trim at the front should be repositioned.</p>

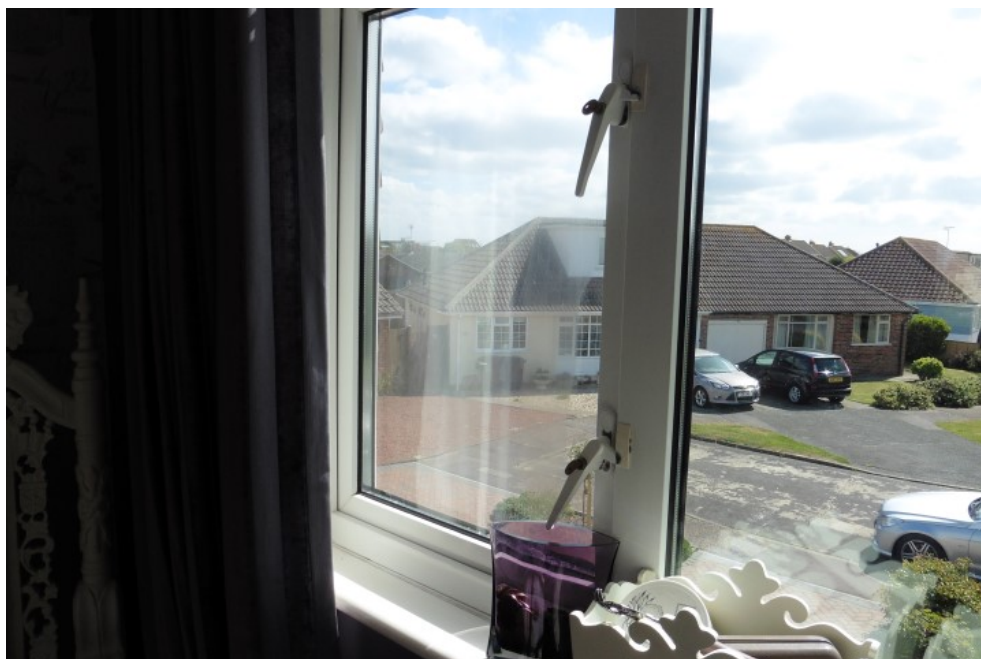
<b>Condition</b>	<p>No significant defects were noted and most of the windows and doors checked were found to operate normally. However, some were found to be quite difficult to operate, probably due to a lack of lubrication of locks and hinges.                  The handle of the bathroom window on the ground floor is stuck in the open position.</p> <p>A failed sealed window unit was noted in bedroom 1, and other weather conditions may highlight the presence of more. This occurs .....</p>		
<b>Action Required</b>	<p>Under normal circumstances sealed double glazed units can be expected to last between 15-20 years before the seals begin to .....</p> <p>Failed sealed double glazing units require replacement. It should also be considered that, where some sealed units within a window have failed, others may also fail in due course.</p> <p>Normal maintenance of frames, hinges and locks is required. This includes repair of the bathroom window and the bedroom 1 seal and frame.</p>

Bedroom 1 casement window panel blown

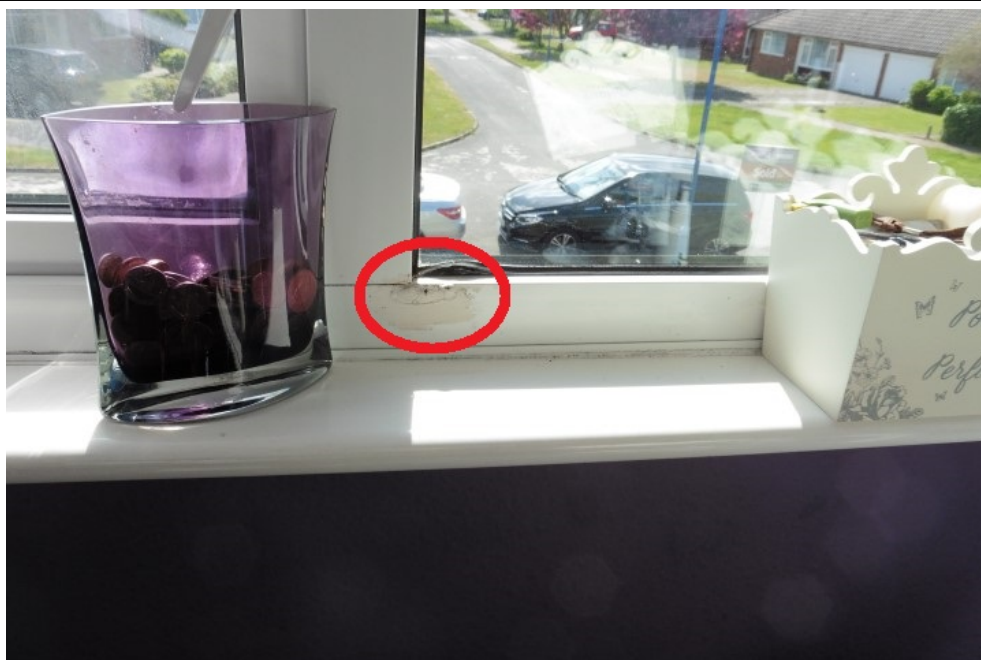
Damage to frame and seal in bedroom 1

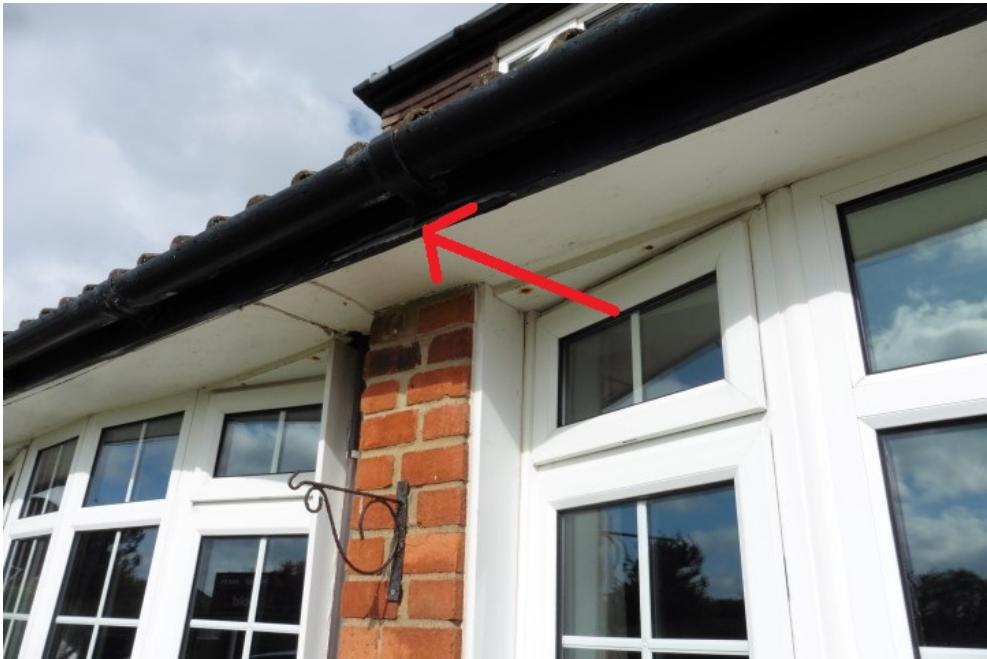
<h2 style="margin: 0;">4.6 External Joinery and Finishes</h2>	<p style="text-align: center;"><b>Condition rating</b></p>	<p style="margin: 0;">3</p>
<p><b>Construction &amp; Type</b></p>	<p>This includes such items as woodwork at the roof edges, trim panels and any timber porch/canopy. Soffits are the horizontal timbers joining the fascia boards to the house walls. Fascia boards are the vertical timbers to which the gutters are normally fixed. Barge boards are the diagonal boards at the roof edge on the gable end of the house.</p>		
<p><b>Nature of inspection and Limitations</b></p>	<p>All such materials were examined from ground level and with the aid of binoculars from vantage points within the grounds of the property and suitable public areas around. Decorations were examined for indications of poor maintenance, rot and other defects.</p>		
<p><b>Condition</b></p>	<p>Widespread evidence was found of rot in the external joinery, including both the fascias at the front and the soffits at the back. The timber is failing and what we have spread to other parts of the building.</p>

</div> <p style="text-align: center;">Rot in the fascia at the front</p>

<p><b>Action Required</b></p>	<p>Urgent repairs are required to replace rotten timbers around the edges of the roof. Although some areas of rot were identified, others may be present, and it is possible that the ends of the roof rafters may have been affected. A thorough investigation should be carried out to identify all rotten timber, which should be cut out and replaced. This work is considered to be of an urgent nature and should be carried out immediately upon occupation of the property.</p>		
	<div style="text-align: center;">

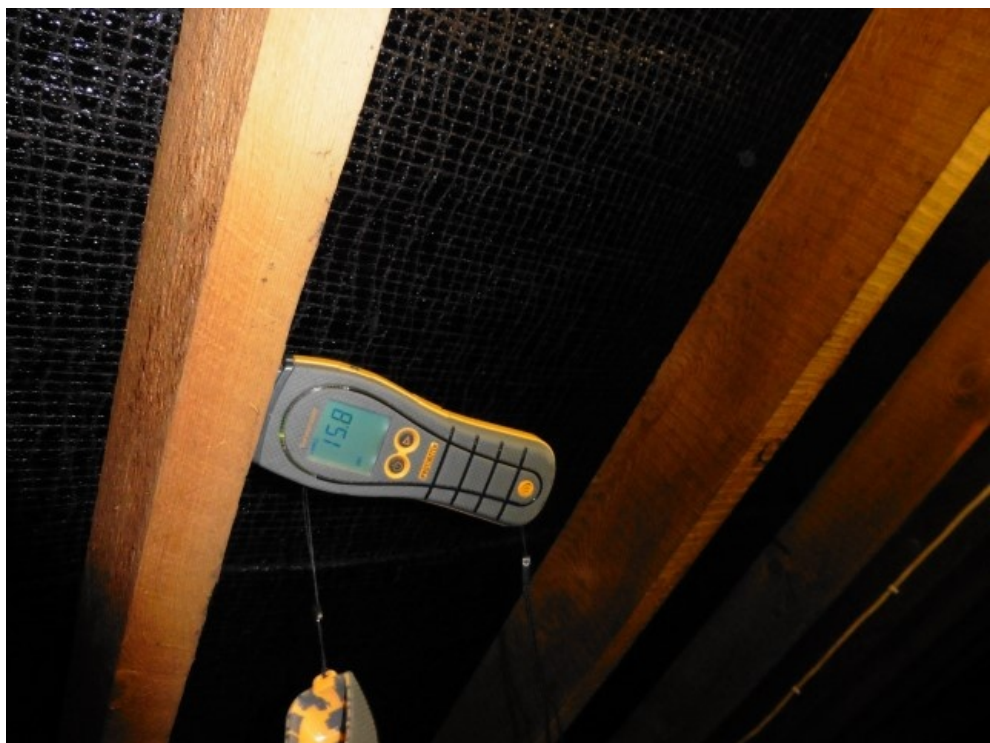
Normal moisture reading in roof timber

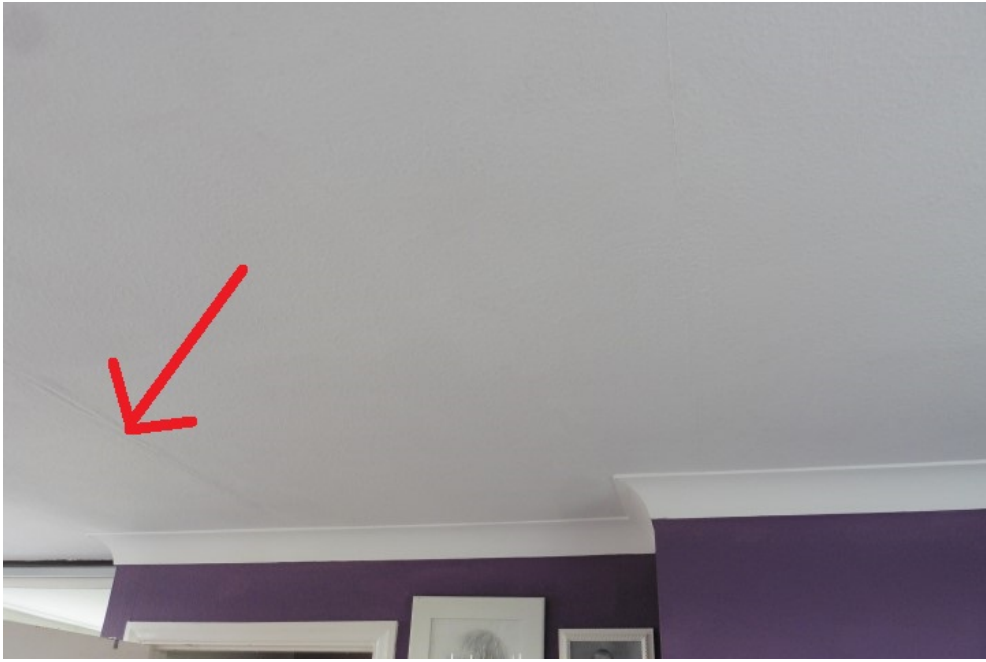
<b>5.2 Ceilings</b>	<b>Condition rating</b>	<b>1</b>
<b>Construction &amp; Type</b>	The ceilings are constructed from plasterboard.		
<b>Nature of inspection and Limitations</b>	They were examined for signs of bowing, cracking, staining and other defects.		
<b>Condition</b>	No significant defects were noted. Some cracking of the ceiling finishes was noted, for example in bedroom 1. These cracks are primarily along the lines of plasterboard joints and are unlikely to be symptomatic of undue movement of the property.		
<b>Action Required</b>	Normal maintenance is required, including filling and redecorating cracks as necessary.		
	<div style="text-align: center;">

<p data-bbox="691 1585 1129 1615">Straight cracks on the bedroom 1 ceiling</p> </div>

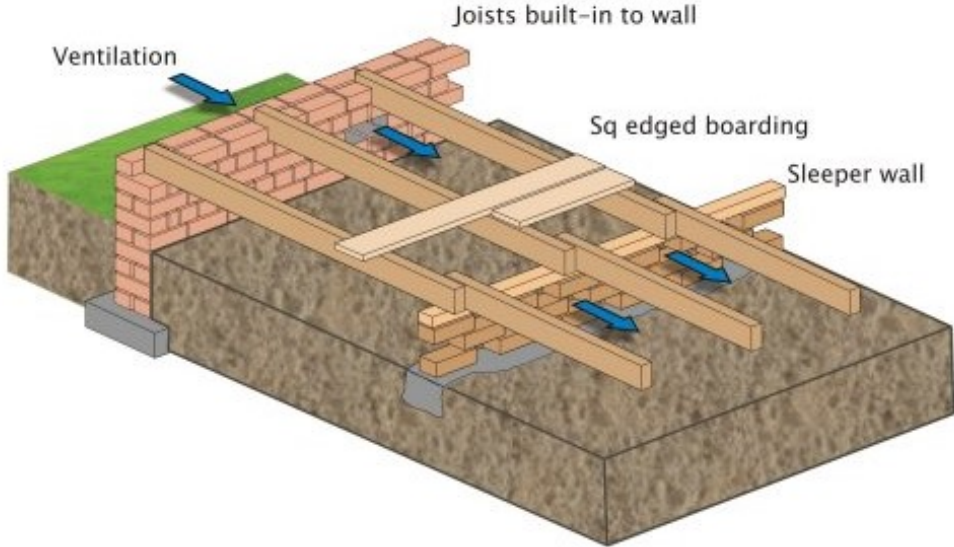
<h2 style="margin: 0;">5.4 Floors</h2>	<b>Condition rating</b>	3
<b>Construction &amp; Type</b>	The floors on both ground and first floors are of suspended timber construction, except for the sun room extension which has a solid concrete floor.		
<b>Nature of inspection and Limitations</b>	Floors were examined for sagging, hogging, unevenness, undue springiness and other signs of failure or damage. Fixed floor coverings in most rooms prevented direct examination of the floor surfaces.		
<b>Condition</b>	Floors on the ground floor were found to be unusually springy and bouncy when walked upon. This can often indicate that the substructure of the floor has become affected by rot or other timber defects, often as a result of a lack of ventilation of the subfloor void. Although it was not possible to gain access to the space beneath the floors, it is anticipated that timbers will be found to have become weakened and possibly broken.

<p style="margin: 0;">Suspended timber floor construction</p> </div>

<b>Action Required</b>	Further investigations are required to explore the sub floor void, particularly in the living room, as the unusual springiness of the floors suggests that some significant timber defects are present. This will require the floor coverings to be lifted and floorboards released. It is thought likely that the supporting timbers joists will require replacement. These works are of a disruptive and major nature and should be carried out immediately upon occupation of the property.		
	<div style="text-align: center;">

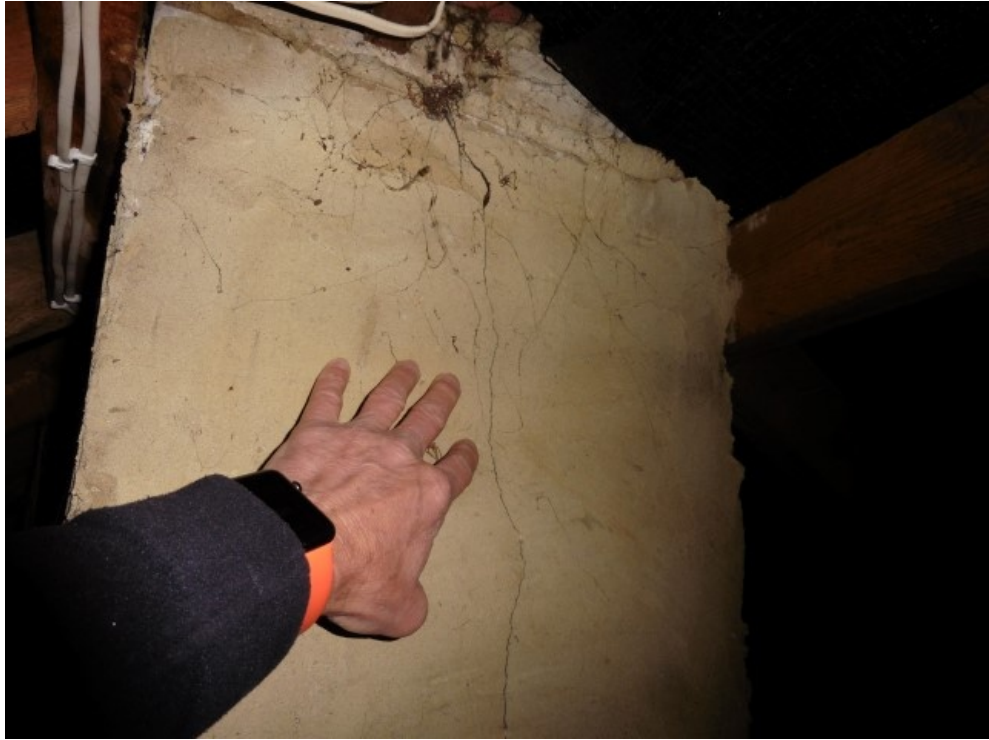
<b>Condition</b>	<p>Although no specific evidence of any structural defects was identified, it is possible that some changes have been made to the right side chimney breast which have the potential to lead to structural failure.</p> <p>Within the kitchen there is no lower part to the chimney breast. Although this type of arrangement is not unusual and was usually accompanied by a flue pipe leading to a boiler or stove beneath, without knowing the history of the building it is impossible to confirm that this is how it was constructed and that is not been altered. In the roof space above there is some light cracking of the chimney breast, and although it is unlikely that this is due to any structural failure, from a single visual inspection it is impossible to be completely sure that this is the case.</p> <p>The left side chimney breast, serving the fireplace in the living room is, as far as can be determined, in a stable condition.</p>

Light cracking of the right side chimney breast in the roof space

<b>Action Required</b>	<p>Enquiries should be made to determine whether any alterations have been carried out to the chimney breast in the past.</p> <p>A structural engineer.....                  .....                  .....</p>

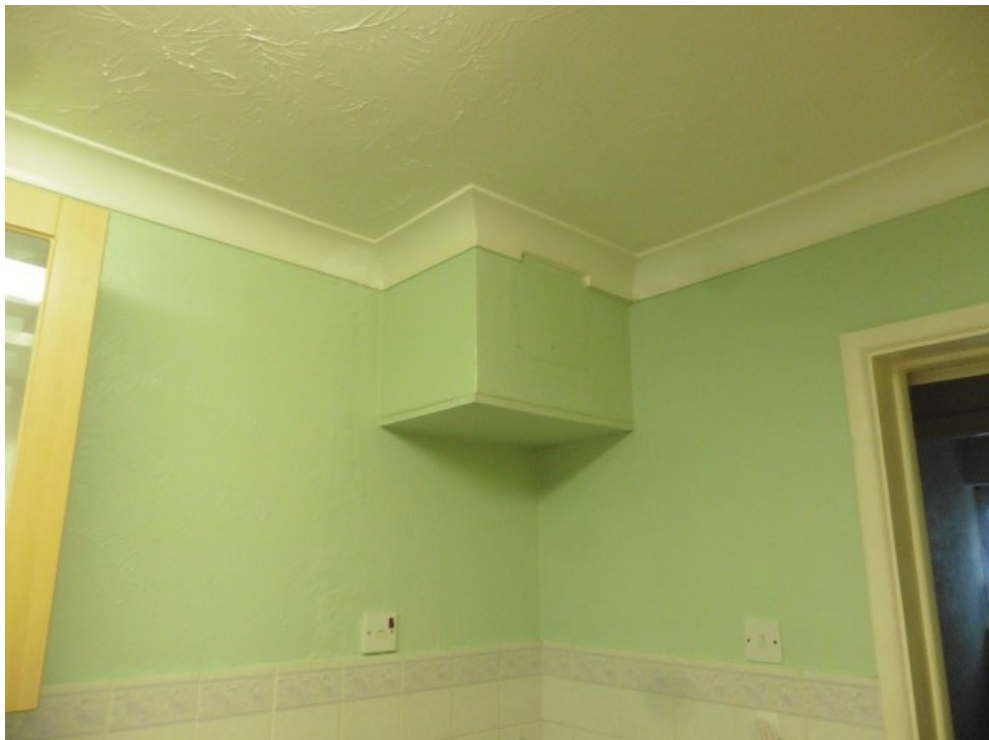
Right side chimney breast in the kitchen has been truncated

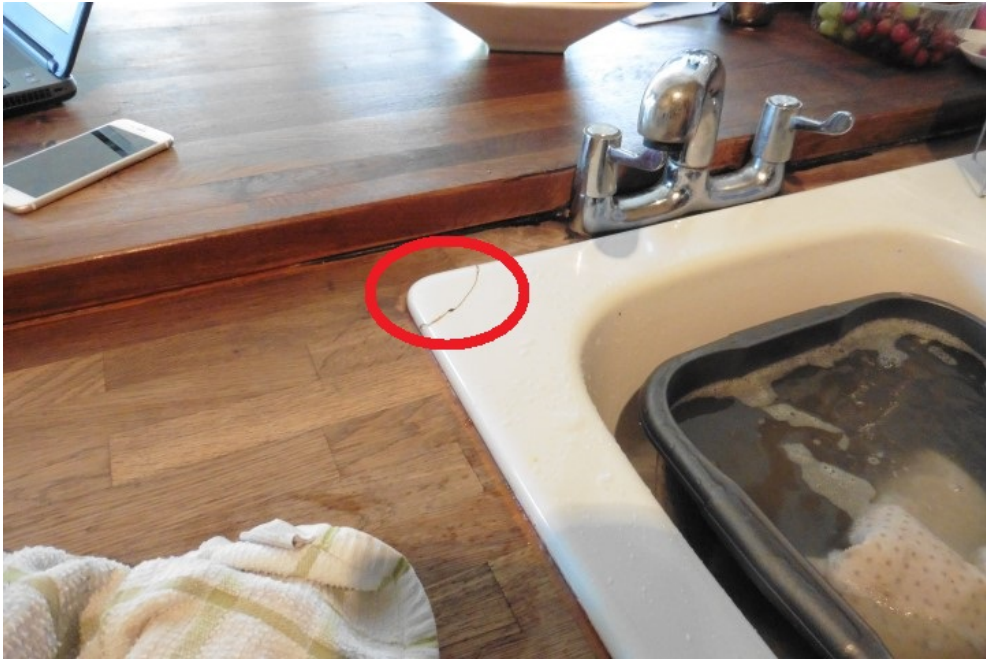
<b>5.6 Built-In Fittings</b>	<b>Condition rating</b>	<b>2</b>
<b>Construction &amp; Type</b>	The kitchen fittings include wall and base units, drawers, sink and worktops. Other built-in fittings include wardrobes and cupboards.		
<b>Nature of inspection and Limitations</b>	The kitchen units were examined for general condition. A selection of cupboards and drawers were checked for normal operation and no significant defects were noted. Built-in appliances were not checked for operation or safety.  Fitted wardrobes (and walk-in cupboards) were checked for general condition and door operation. No significant defects were noted but some modernising and updating may now be required.		
<b>Condition</b>	The kitchen fittings are of a modern style and in a serviceable condition. It is understood that they were installed by the current owners. The flow of water at the sink was checked and was within a normal range and considered to be suitable for the intended use. Hot water was obtained from the kitchen hot tap. Fitted cupboards and wardrobes are of a basic style and, generally in a serviceable condition. The cooker hood was found to be noisy in operation. The edge of the kitchen sink is cracked and will require repair.

<p style="text-align: center;">Cracked edge to the kitchen sink</p>

<b>Action Required</b>	Maintain, repair or replace units as necessary. The fan within the cooker hood should be replaced. The kitchen sink will require replacement as it is cracked.

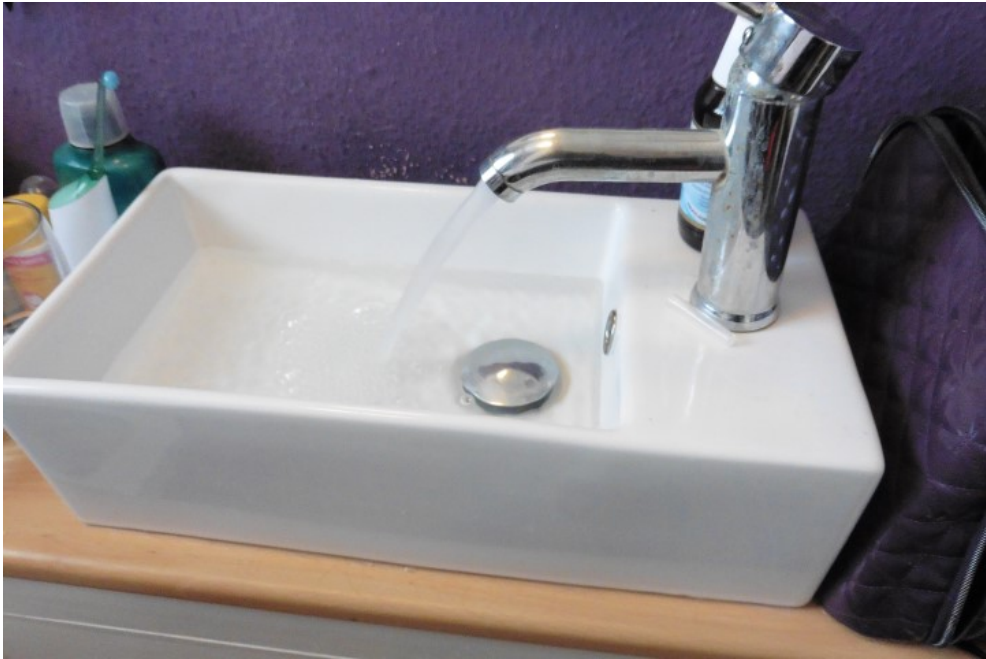
</div> <p style="text-align: center;">First floor WC basin has no hot flow and poor drainage</p>

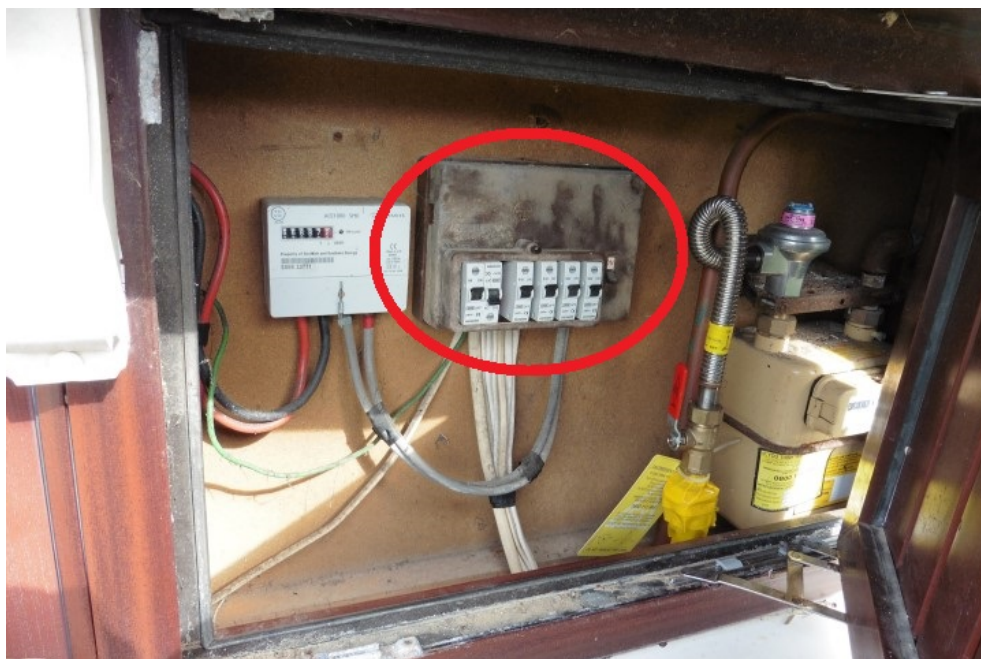
<b>Condition</b>	<p>The fuse board is of an older type without the more modern RCD protection devices installed, suggesting that it has not been upgraded recently. It must be assumed, therefore, that much of the installation dates from the 1970s or before and is, therefore, out of date.                  Although it was impossible to see most of the sockets in the rooms around the house, extension leads suggests that there are insufficient outlets for modern purposes.                  Power supplies to the sheds within the garden are, clearly, of an amateur nature and unlikely to meet reasonable safety standards. These supplies were noted to be of non-armoured cable.</p>		
<b>Action Required</b>	<p>The NICEIC recommends that electrical installations are subjected to an Electrical Installation Condition Report (EICR) by a competent person at least every .....</p>

Fuse board

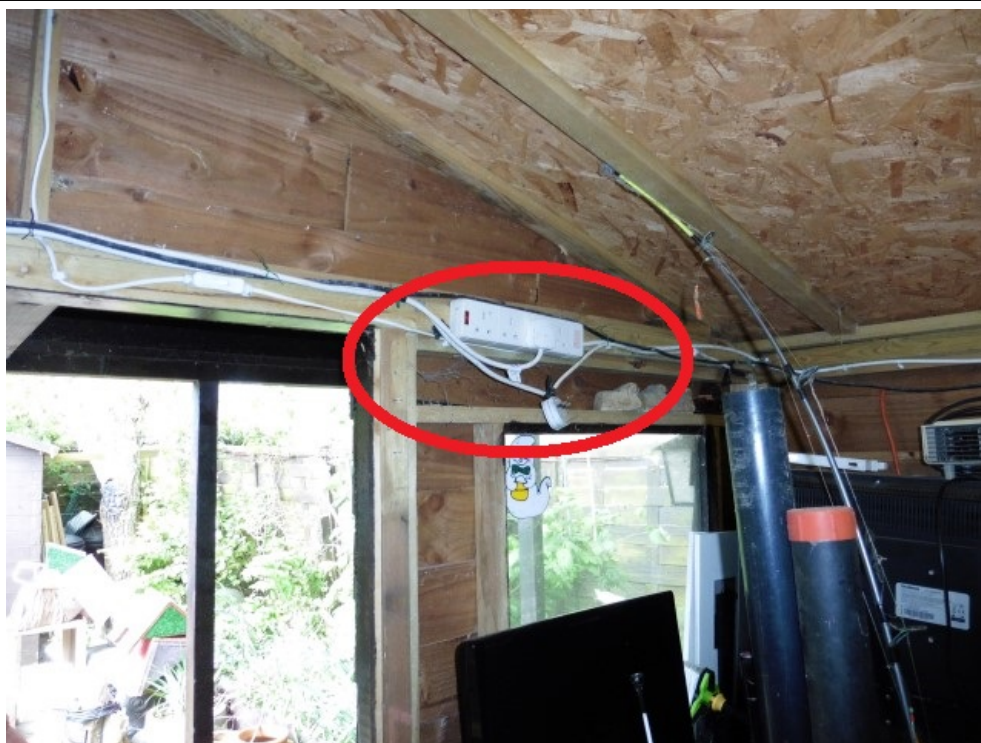
Poorly managed wiring in shed 4

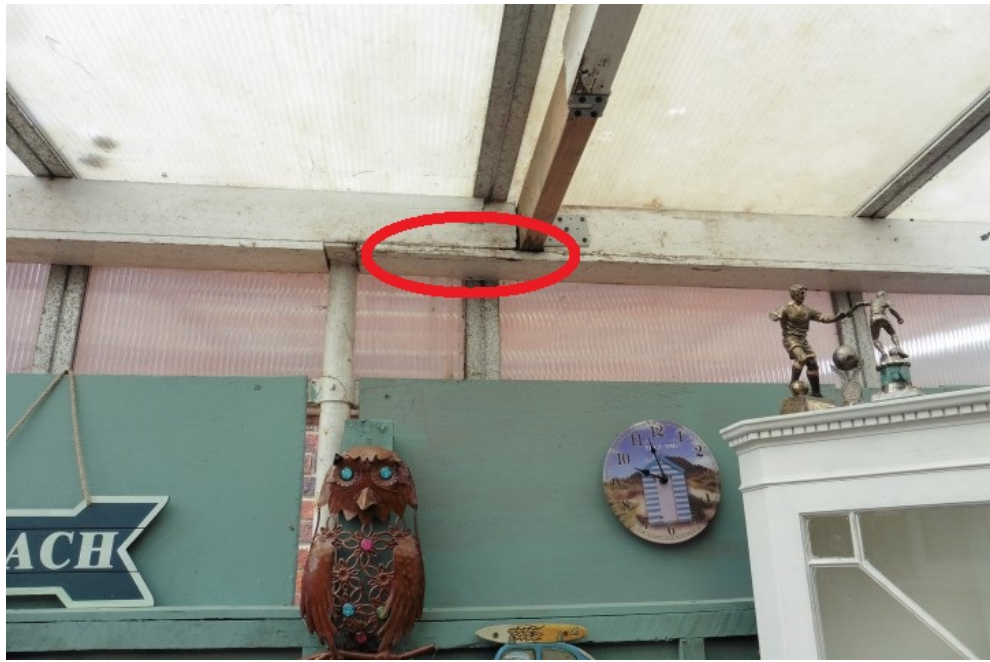
Possibly rotten timbers in the lean-to

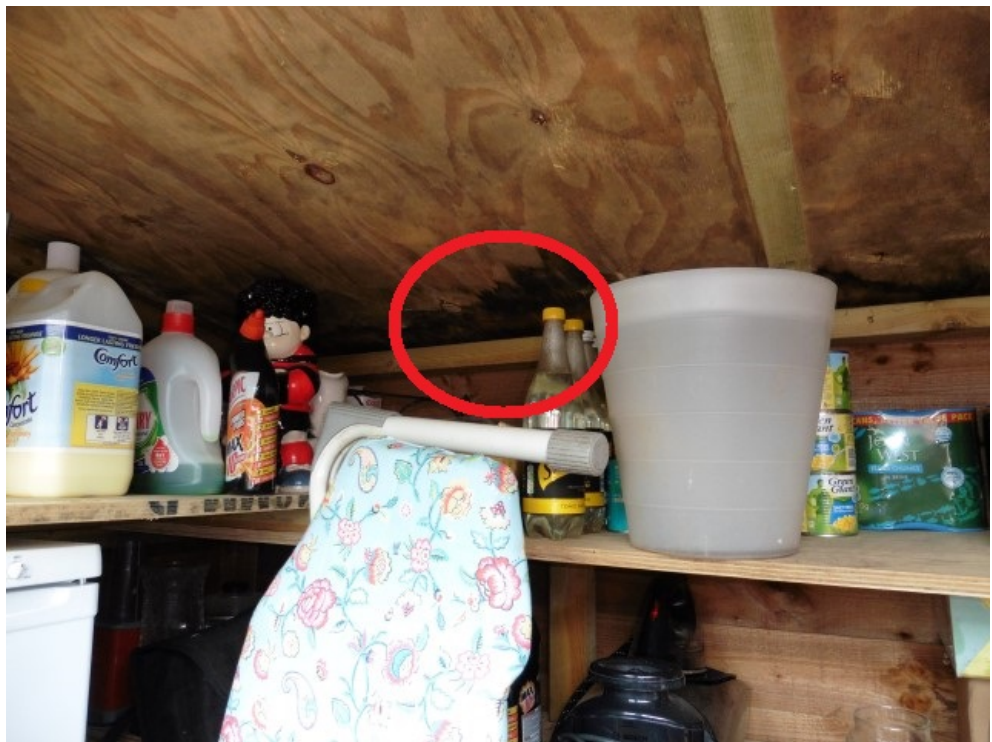
Staining on the underside of the roof of shed 2

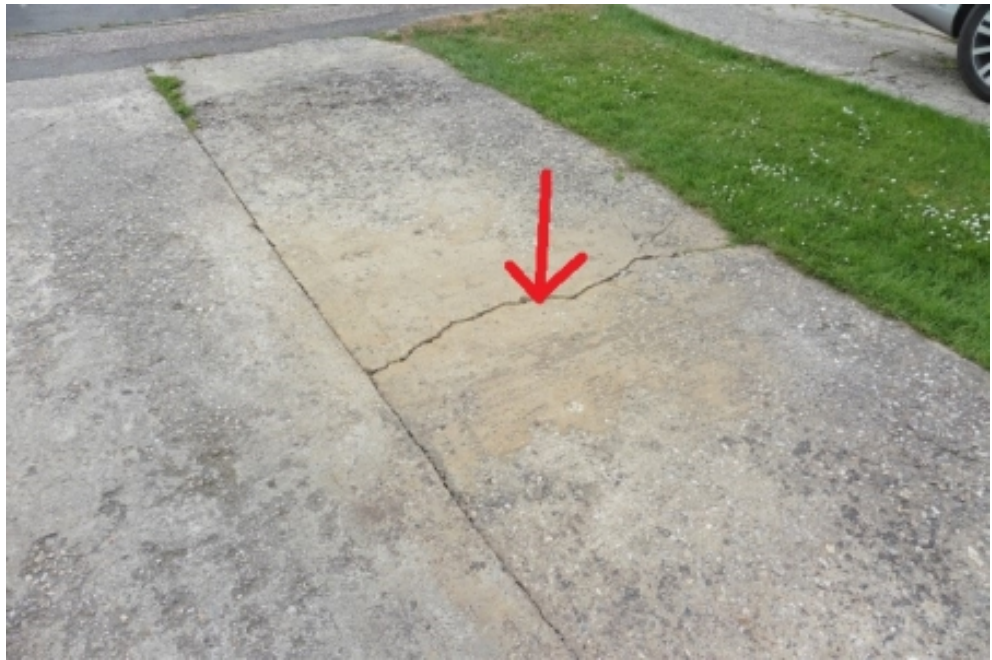
Cracking in the front drive

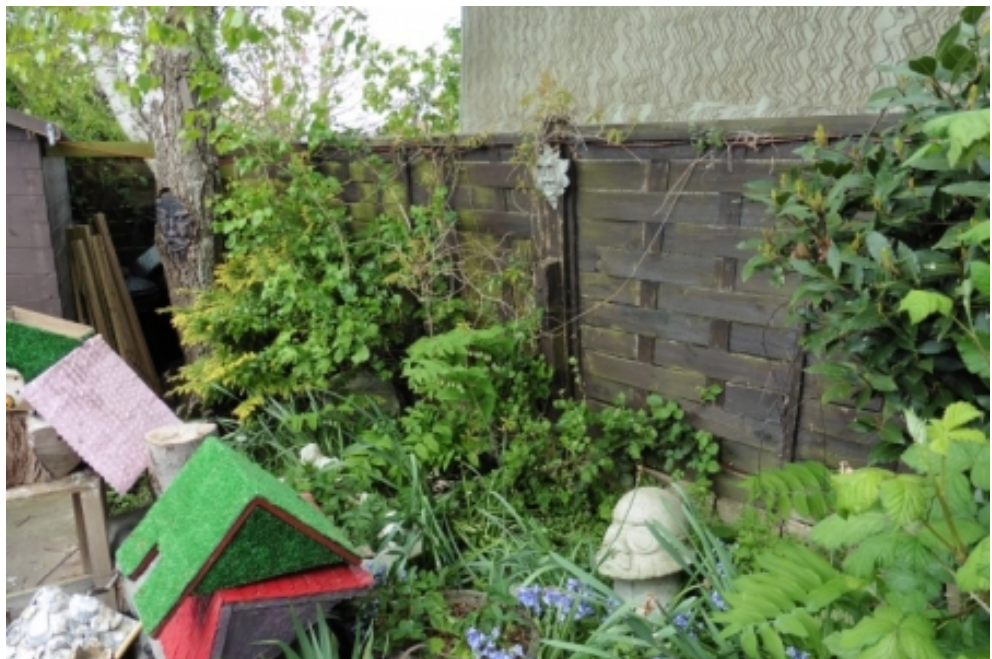
Rear boundary fencing maybe loose
