SURVEY DATE 1 Sep 2018

BUY-TO-LET SURVEY REPORT

INCLUDING CONDITION and HEALTH & SAFETY REVIEW

REF 2788

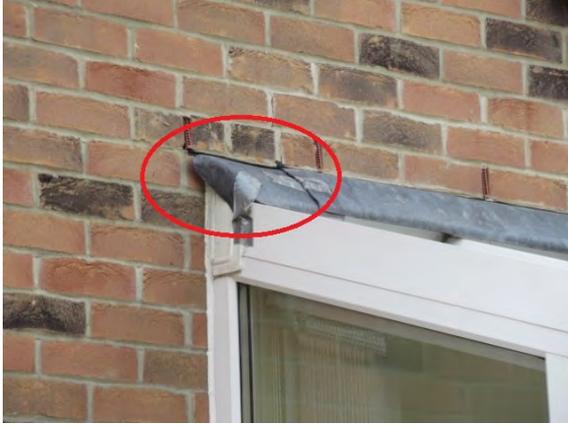
<p>Front and right side roof pitches</p>	<p>Right side roof pitch</p>
	<p>Loose and taped flashing for the living room extension roof at the back</p>	<p>Roof Elements</p>

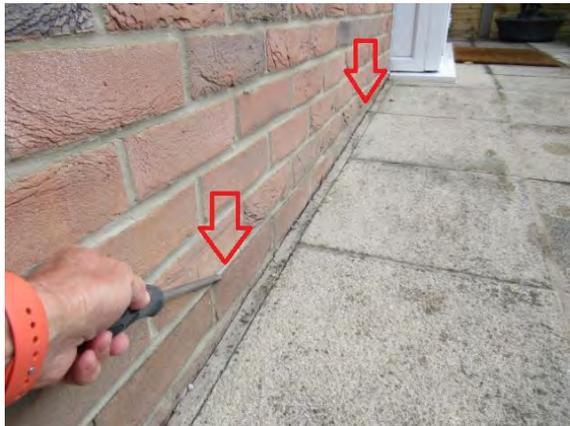
Level of damp proof course at the front is below the paving around the front porch viewed from the front

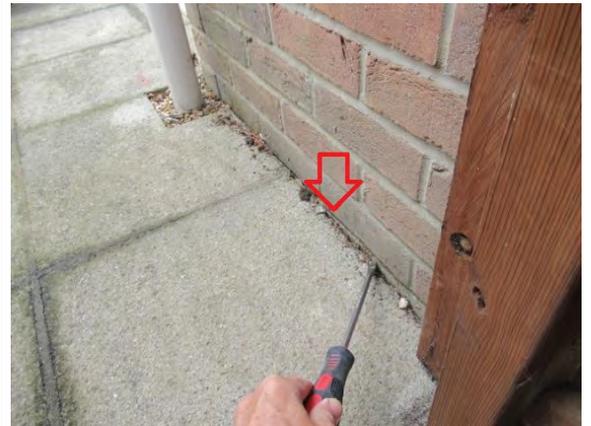
Level of damp proof course on the right side adjacent to the porch

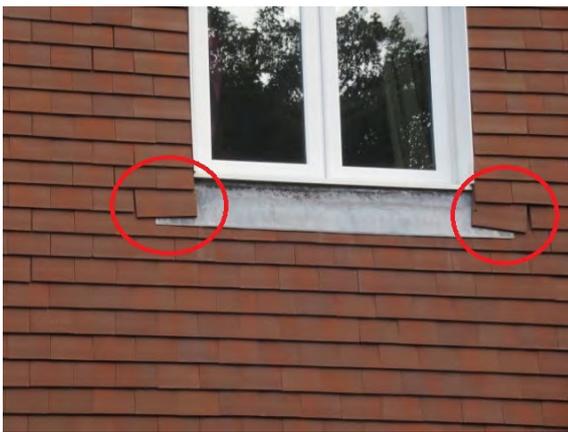
<p style="text-align: center;">Misaligned tiles at the front</p>	<p style="text-align: center;">Example of Stretcher bond</p>

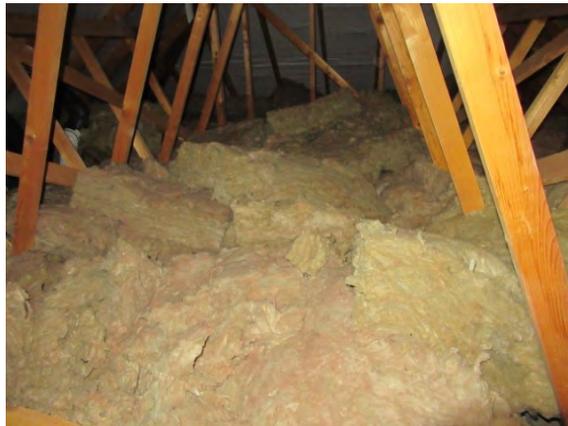
<p>Uneven insulation</p>

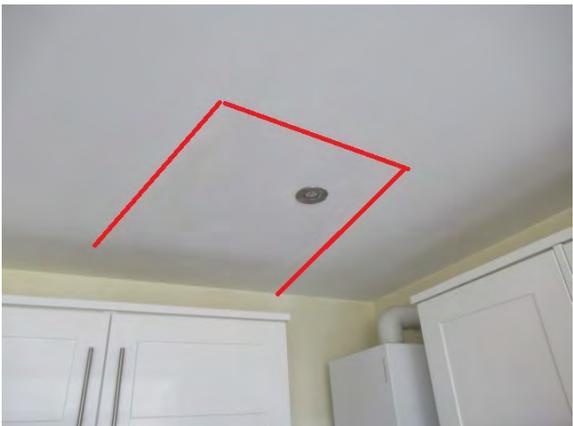
<p>Condition</p>	<p>No significant defects were noted. No evidence was seen of any unusual unevenness, cracking, bowing or other failure. A stain on the kitchen ceiling, near to the boiler, is immediately below the en-suite shower room. The sellers indicated that the stain was caused by water escaping from the shower after the door was left ajar. While it is assumed that this is a genuine explanation, of course, it cannot be confirmed. However nothing was seen to suggest that this is an ongoing matter.</p> <p>Some cracking of the ceiling finishes was noted. These cracks are primarily along the lines of plasterboard joints and are unlikely to be symptomatic of undue movement of the property.</p> <p>Normal maintenance is required, including filling and redecorating cracks as necessary.</p>

<p>Staining in the kitchen near to the boiler</p>

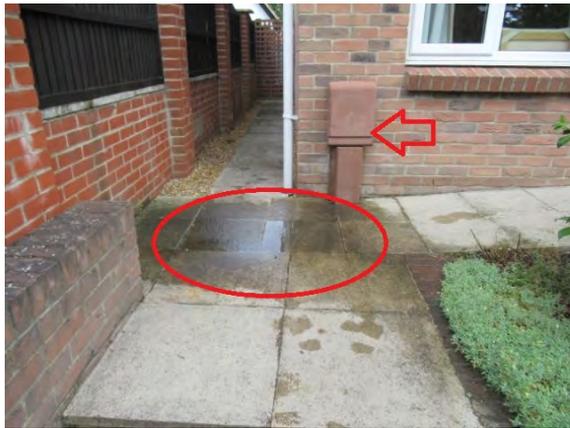
Condition	<p>At the front of the house a wet area was noted on the paving in the area immediately in front of the water meter housing. This could be caused by a leak from the main water supply to the house. If this were the case then a leak of this type can lead to the ground beneath becoming unstable, causing the house to subside as the foundations fall into the ground which has been washed away.</p> <p>The sellers indicated that they had had the installation inspected by the water authority and that it had been confirmed that the wetness was not due to a leak but it was an area which took longer to dry after rainfall. Indeed, it had rained in the days prior to the survey inspection which could corroborate this version of events.</p> <p>However, as it is impossible to confirm this to be the case, from a single inspection of the property, further investigation is recommended, initially by enquiries of the sellers, until it can be satisfactorily proven that no leak is present.</p> <p>These enquiries are considered to be of an urgent nature and should be carried out before exchange of contracts.</p> <p>If it is the case that the wetness is simply due to rainfall, then some further inspection should be made to identify the pathway by which rain runs off surfaces above this area to identify whether some other factor may be causing it.</p> <p>In all other respects the installation was found to be in a serviceable condition. Hot water was obtained from all hot tap outlets, and the flow of water was found to be within a normal range.</p> <p>Check the installation for evidence of leaks or other defects on a regular basis i.e. approximately every 6 months, or sooner. Leaks most often occur at pipe joints and where pipes are subject to movement or physical damage, such as airing cupboards, roof spaces and under sinks.</p>

Wet path adjacent to water meter housing

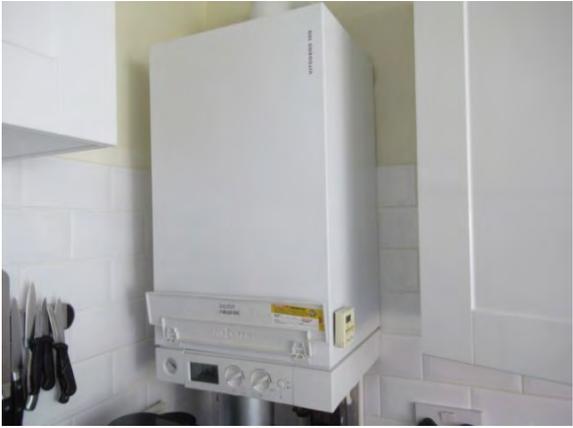
<p style="text-align: center;">Boiler</p>

<p>Condition</p>	<p>No evidence was available to suggest that the boiler has been recently serviced. However, the sellers indicated that it was due to be serviced in the days immediately following the survey inspection. The boiler is that which was installed at the time of construction of the house, and so is around 7 years old. Under normal circumstances a modern boiler will last for 15-20 years before requiring replacement.</p> <p>Gas Safe recommends that all gas appliances and boilers are inspected and serviced according to manufacturer's guidance, but at least once a year. A gas installation can look to be in a safe condition, but serious defects may be hidden, some of which can kill. It is therefore considered to be essential that you commission an inspection of the gas/heating installation prior to purchase of the property, unless you are provided with verifiable evidence that such an inspection has recently been carried out by a competent person. You can get more information, or find a Gas Safe registered engineer https://www.gasaferegister.co.uk/find-an-engineer/</p>
