# Schedule of Condition Report

**PROPERTY** SAMPLE REPORT  
FOR DEMONSTRATION  
PURPOSES ONLY  
D3 M30

**SURVEY DATE** 25 Jan 2024

**REF** 34329

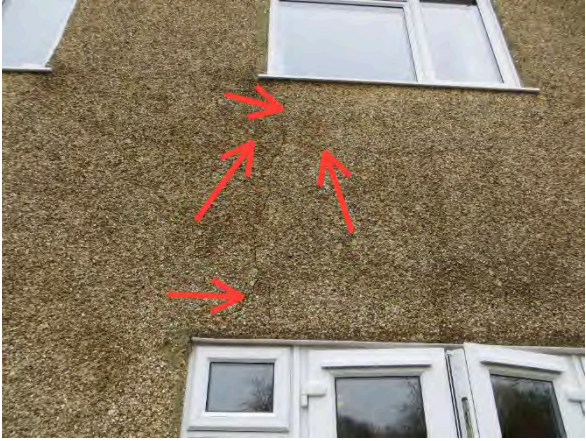
<p>Cracking of the render from below the right side of the first floor bedroom window to the top of the opening of the rear French doors on the ground floor. The crack is approximately 3-4mm wide and has branch cracking to the left and right approximately 24cm below the first-floor window.</p>
<p>Rear Elevation</p> <p>Walls</p>

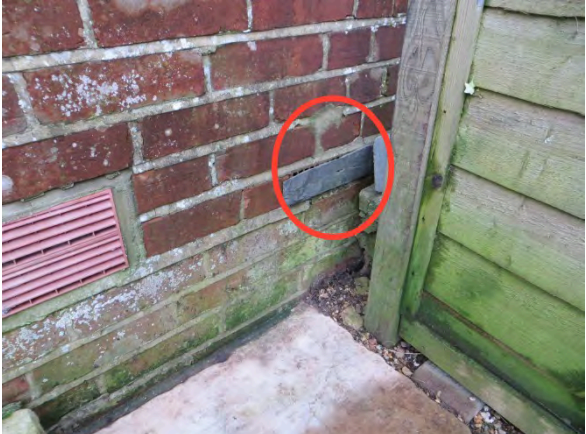
<p>Displaced slate blanking plate over the airbrick that straddles the boundary line to the left side, with previous mortar repairs to the brick joints immediately above.</p>

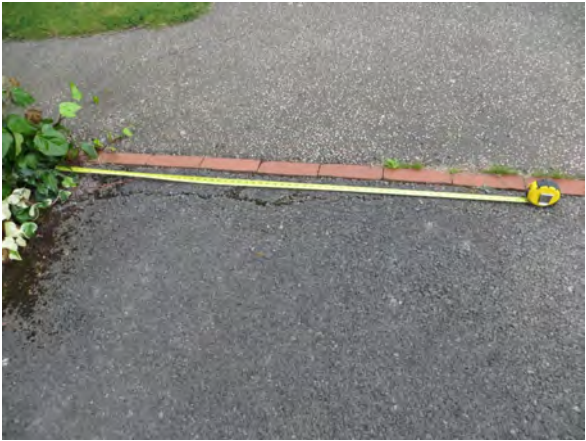
<p>The drive is a total of approximately 30m<sup>2</sup> and slopes down from the footpath at the front.</p> <p>There is general age related cracking of the surface. There are 5 main cracks.</p> <p>Crack 1 near to the footpath end of the drive running left to right, approximately 1.35 metres long, v-shaped to a maximum of approx 8mm width.</p>
<p>Front of Property</p> <p>Other</p>

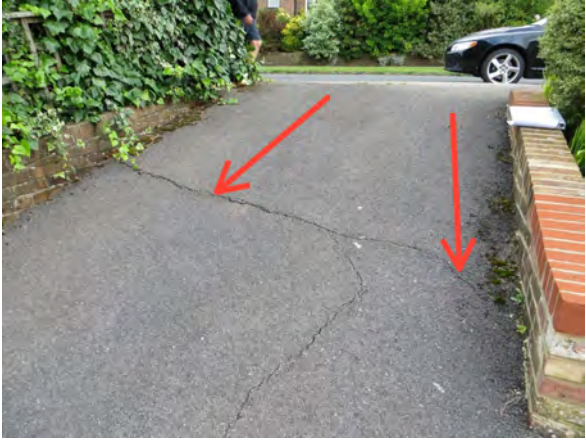
<p>Crack 2 approximately 1/3 of the distance from the footpath, across the full width of the drive from 0mm on the left side to a maximum of 25mm on the right side.</p>
<p>Front of Property</p> <p>Other</p>

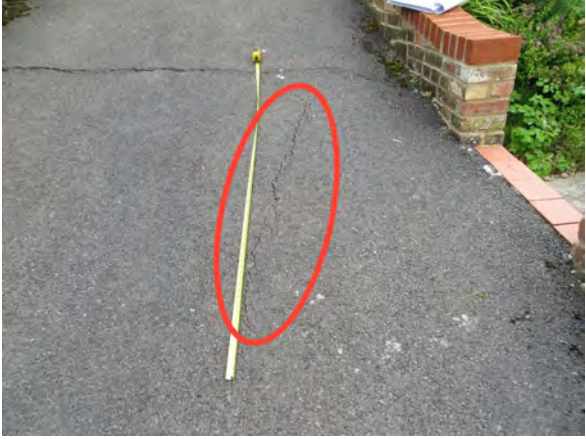
<p>Crack 3 approx mid way along the drive running front to back, approx 1.8 metres long with a jagged shape to a maximum of approx 5mm width nearest the front.</p>

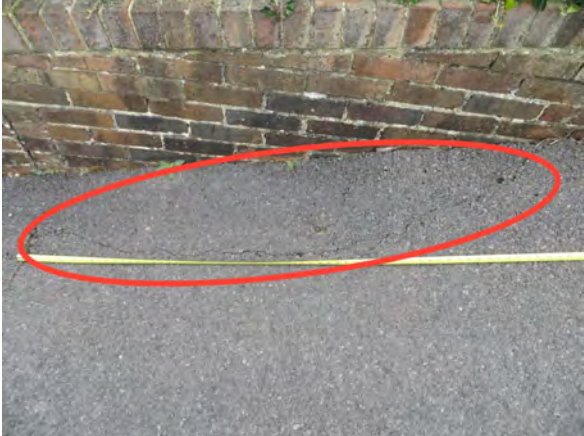
<p>Crack 4 is a jagged crack 1-2mm wide close to the the right side boundary wall being curved and approx 1.6 metres long.</p>
<p>Front of Property</p> <p>Other</p>

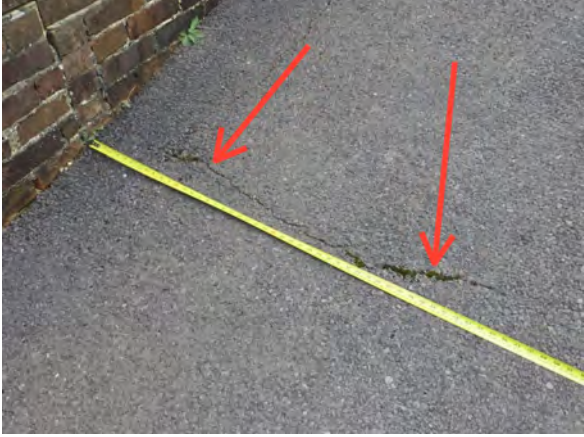
<p>Crack 5 is a crack running across the drive from the right side for approx 1.10 metres, being jagged and approx 1-3mm wide.</p>
<p>Right of Property</p> <p>General Grounds</p>

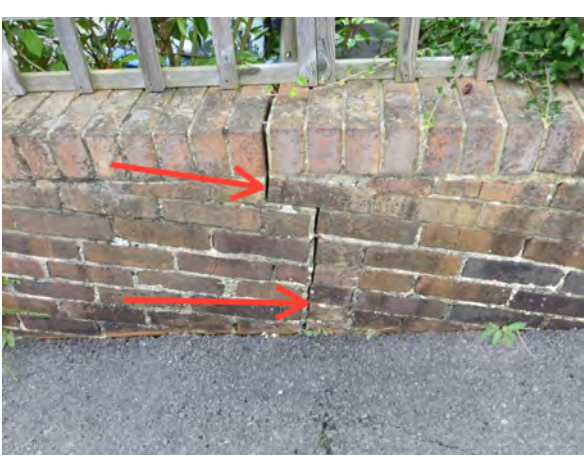
<p>The brick dwarf wall to the right side of the drive is approximately 10.5 metres from the footpath to the garage. Approximately 5.5 metres from the footpath end there is a vertical crack in the perpend mortar joints throughout the whole height of the wall. The crack is v-shaped being approximately 2-3mm wide at the bottom, widening to 5-6mm at the top. There is a slight lateral shift of the two parts of the wall of approximately 5mm.</p> <p>Approximately 1 brick length away from the vertical crack 4 courses up from the base of the wall there is a single cracked brick. The crack is not extended.</p>

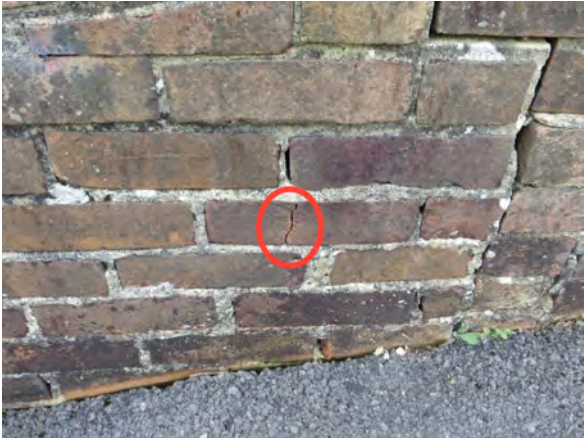
<p>Approximately 1 brick length away from the vertical crack 4 courses up from the base of the wall there is a single cracked brick. The crack is not extended.</p>
---------------------------------------	---	---

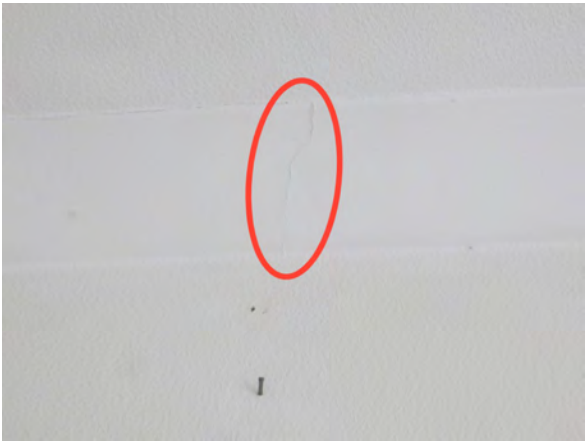
<p>Jagged hairline crack in the coving roughly in the centre of the chimney breast</p>
<p>Bedroom 2</p> <p>Walls</p>

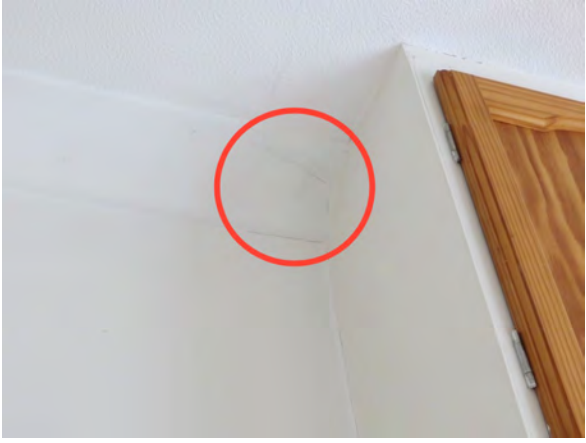
<p>Jagged diagonal hairline crack approx. 100mm long across the coving to the side of the rearward wardrobe.</p>
<p>Bedroom 3</p> <p>Built-In Fittings</p>

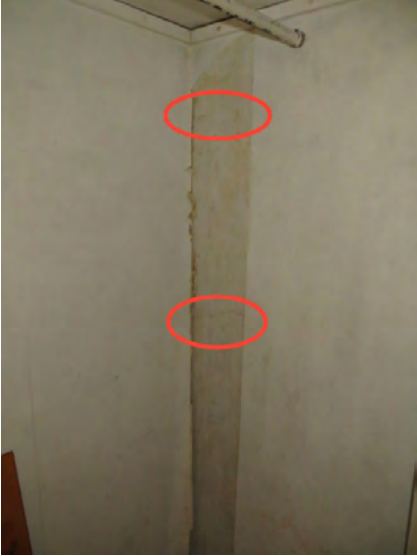
<p>Jagged horizontal hairline cracking on the back wall inside the wardrobe. Two visible cracks approximately 1.0 and 1.5 metres up from floor level</p>

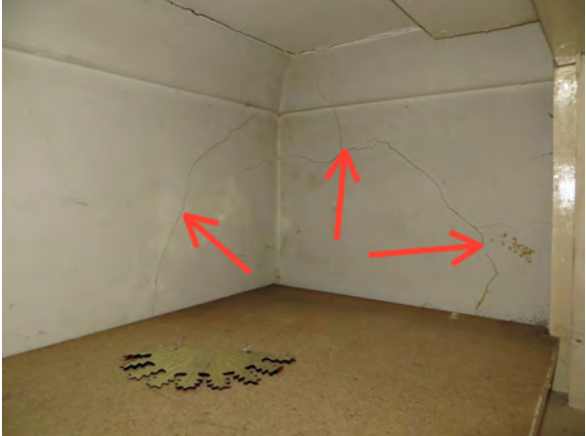
<p>Jagged diagonal cracking hairline to 1.5mm wide in left rear corner of upper wardrobe cupboard at approx. 45 degrees from the top left corner, and associated tributary cracks</p>
<p>Reception 1</p> <p>Ceilings</p>

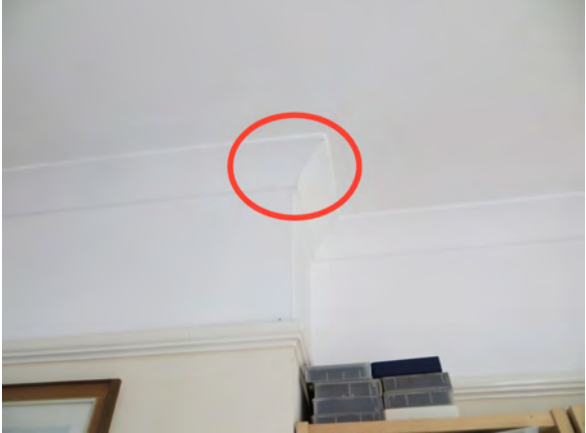
<p>Repaired cracking across the corner of the coving on the chimney breast, approximately 1260mm forward of the rear wall. The cracking has not reopened since previous repair</p>
<p>Reception 1</p> <p>Ceilings</p>

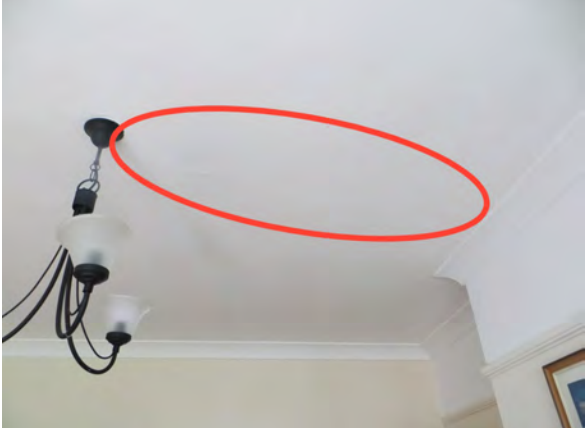
<p>Repaired crack from the front edge of the coving on the chimney breast, diagonally rearward to the centre light fitting. The crack has not reopened since repair</p>

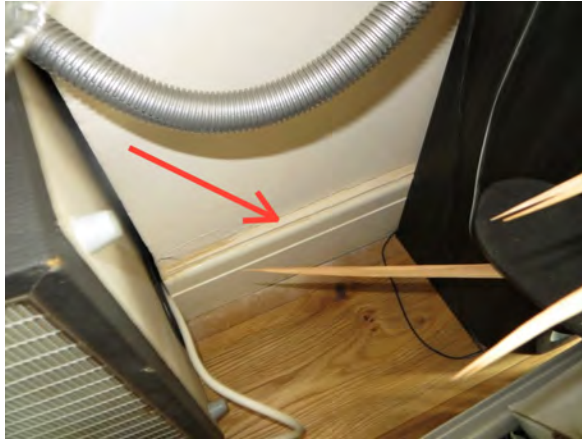
Reception 2

Hairline cracking of the joint between the plaster and the skirting board on the front of the chimney breast. The skirting was only partially visible.
