New Build Inspection Report

CLIENT SAMPLE Survey

SURVEY DATE 1 Mar 2023

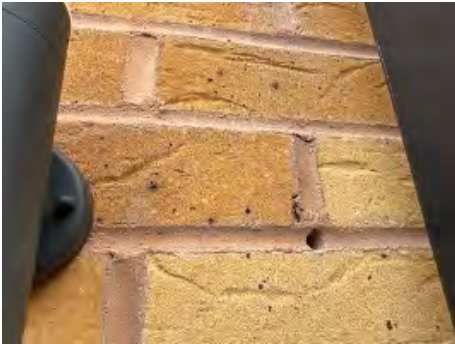
<p>Drill hole through outer leaf of brickwork to be filled. Located on the front elevation.</p>	<p>General Builder</p>
<p>Front Elevation</p> <p>Walls</p>

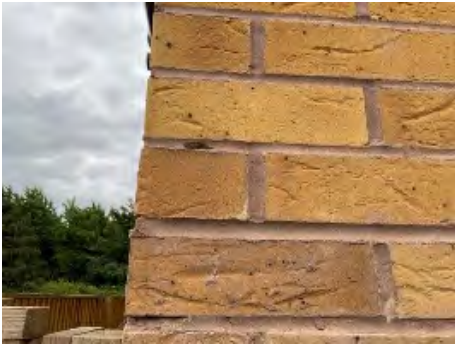
<p>Missing mortar to be filled. Location front elevation on left hand side.</p>	<p>General Builder</p>
<p>Front Elevation</p> <p>Walls</p>

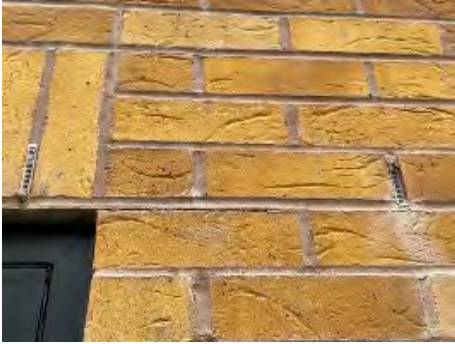
<p>Partially blocked weep holes in various places. Here on the front right elevation.</p> <p>A timber framed construction incorporates weep holes above the damp proof course. All weep holes should be fully clear and pointed in order to allow maximum ventilation within the cavity to protect the timber frame from raised moisture levels.</p>	<p>General Builder</p>
<p>Front Elevation</p> <p>Walls</p>

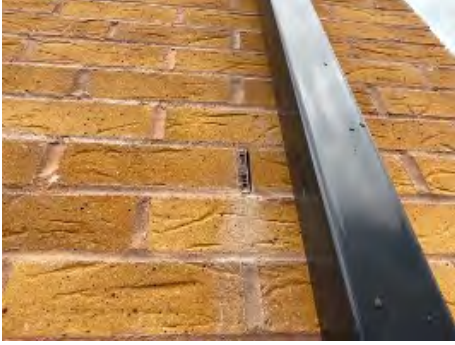
<p>Partially blocked weep hole on front right elevation.</p>	<p>General Builder</p>

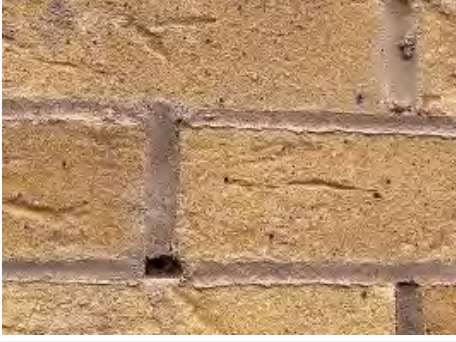
<p>Missing mortar to be filled. (Located below the boiler flue)</p>	<p>General Builder</p>
<p>Rear Elevation</p> <p>Walls</p>

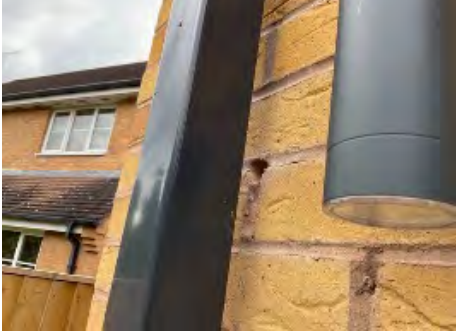
<p>Drill hole through the outer leaf of brickwork to be filled. (Rear elevation left side looking back towards the house)</p>	<p>General Builder</p>

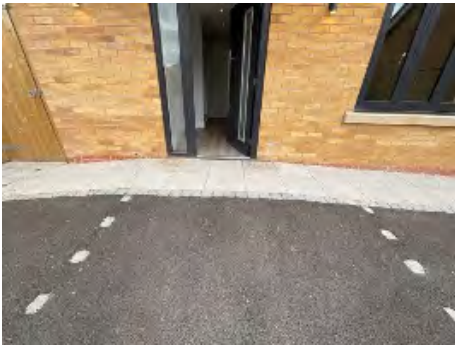
<p>The front path is level with the door threshold breaching the damp proof course.</p> <p>The damp proof course should be 150mm above the finished ground level.</p>	<p>General Builder</p>
<p>Front of Property</p> <p>General Grounds</p>

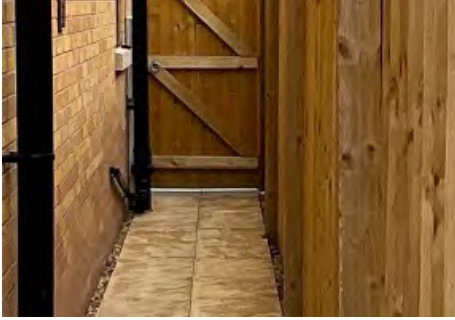
<p>There is slight movement in the concrete paving slab on the left side path near the gate (the slab with the cut-out for the fence post)</p>	<p>General Builder</p>

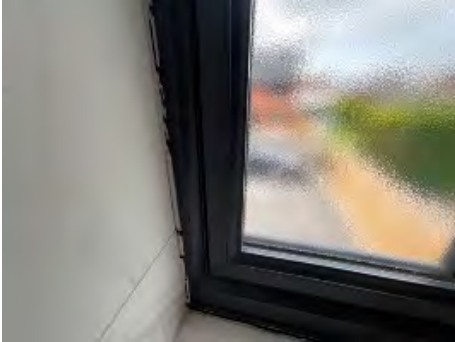
The window frame requires sealing to the window reveal.	Decorator
Bathroom 1 Joinery

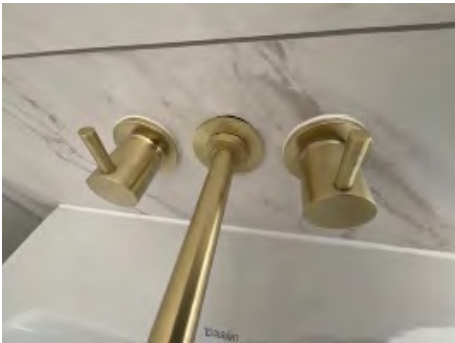
The handbasin mixer tap body is loose and the escutcheon plate does not cover the hole in the wall tiling.	Plumber
Bathroom 1 Joinery

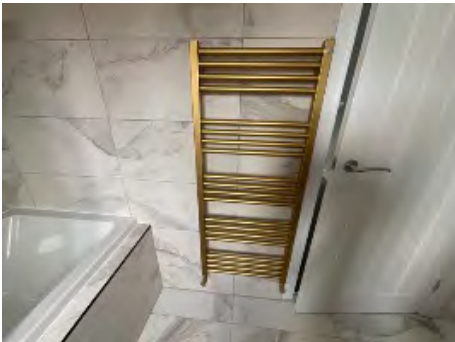
The bathroom door is fouling on the frame and requires easing.	Carpenter

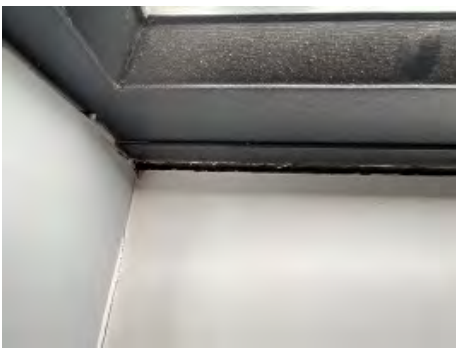
<p>The window frame requires sealing around the cill and the reveal.</p>	<p>Carpenter</p>
<p>Bedroom 1 Joinery</p>

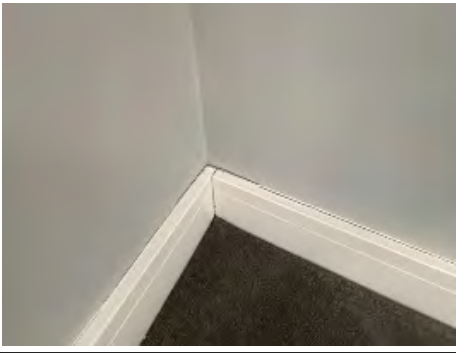
<p>The skirtings and door architraves have shrinkage gaps requiring caulking.</p>	<p>Decorator</p>
<p>Bedroom 1 Joinery</p>

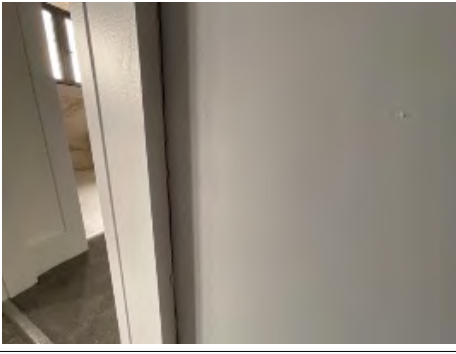
<p>The skirtings and door architraves have shrinkage gaps requiring caulking.</p>	<p>Decorator</p>
<p>Bedroom 1 Walls</p>

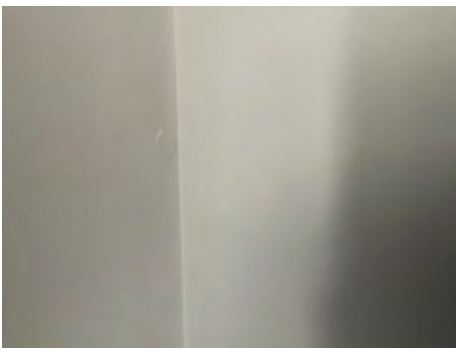
<p>The dry lining has popped screw heads requiring making good.</p>	<p>Decorator</p>
<p>Bedroom 1 Joinery</p>

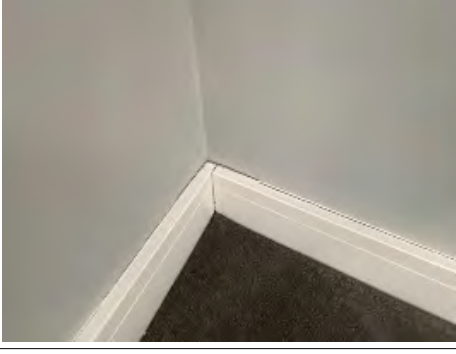
<p>The skirtings and door architraves have shrinkage gaps requiring caulking.</p>	<p>Decorator</p>
<p>Bedroom 2 Joinery</p>

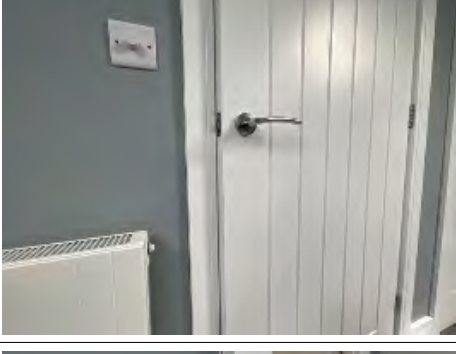
<p>The bedroom door is fouling on the frame and does not close.</p>	<p>Carpenter</p>
<p>Bedroom 2 Joinery</p>

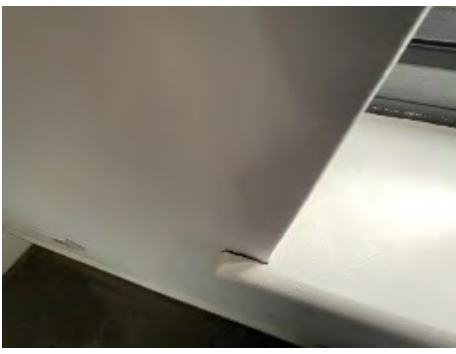
<p>Poorly fitting window cill.</p>	<p>Carpenter</p>
<p>Bedroom 3 Joinery</p>

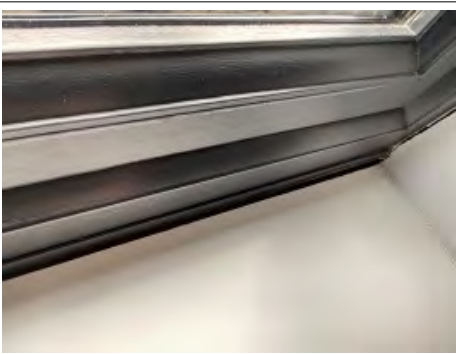
<p>Window frame to cill and reveal requires sealing.</p>	<p>Decorator</p>
<p>Bedroom 4 Joinery</p>

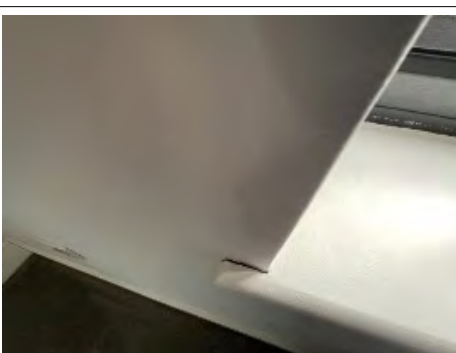
<p>The window cill is a poor fit.</p>	<p>Carpenter</p>
<p>Bedroom 4 Walls</p>

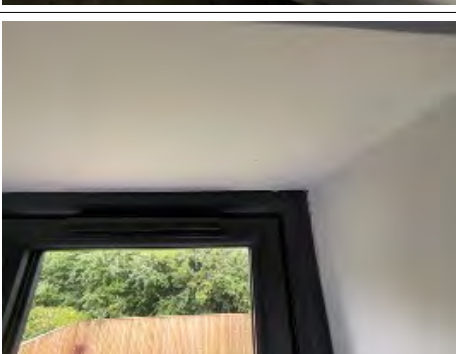
<p>The dry lining screw heads have popped in the window reveal.</p>	<p>Decorator</p>

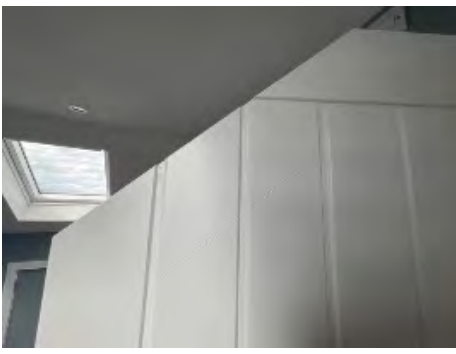
<p>The en-suite door is marked with a diagonal scratch on both sides and requires making good.</p>	<p>Decorator</p>
<p>Entrance Hall Services</p>

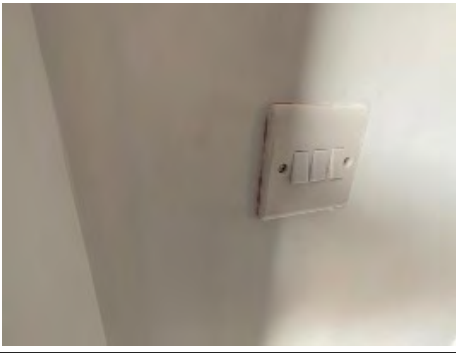
<p>The light switch in the hallway is loose hence a poor decorative finish to its surround.</p>	<p>Electrician</p>
<p>Entrance Hall Walls</p>

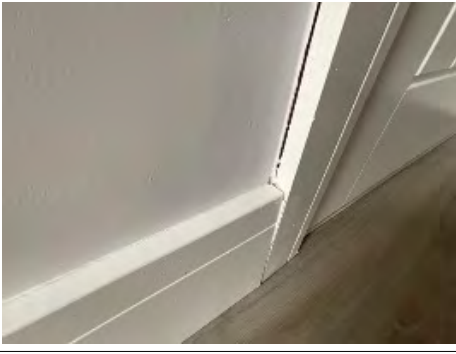
<p>The architrave around the cloakroom doorframe is coming away and creating a gap with the joint with the wall.</p>	<p>Carpenter</p>
<p>Entrance Hall Walls</p>

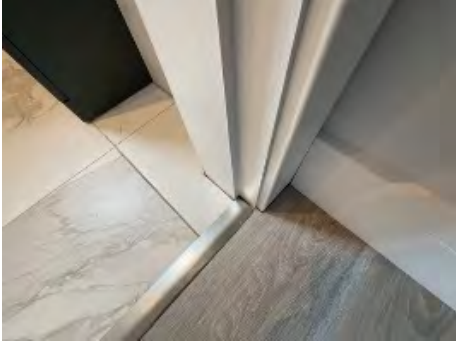
<p>The joint between the laminate flooring and the door architrave should be sealed to prevent moisture ingress to the laminate.</p>	<p>Carpenter</p>
<p>Entrance Hall Joinery</p>

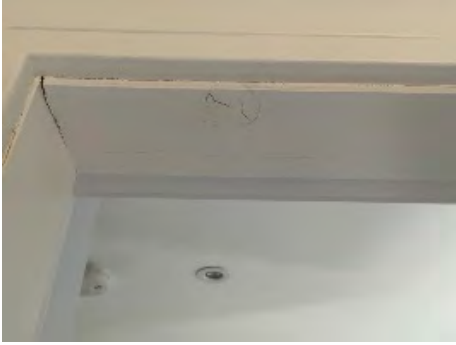
<p>The finish of the door frame/architrave is poor with gaps at joints and knots in the wood opening up.</p>	<p>Decorator</p>
<p>Entrance Hall Joinery</p>

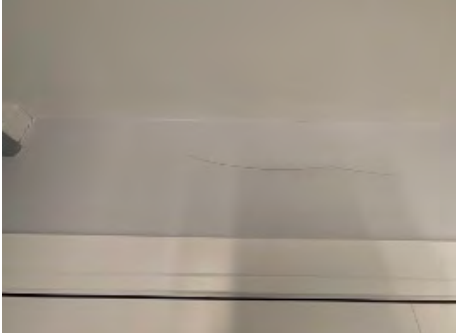
<p>Hairline cracking above utility room cupboard door frame.</p>	<p>Decorator</p>

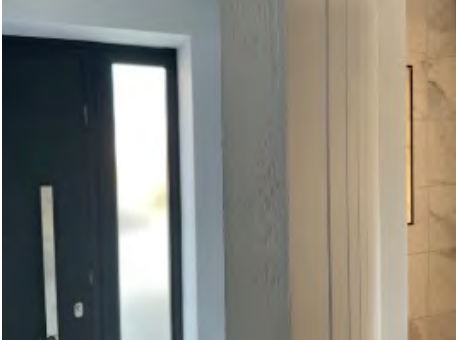
<p>Rough edge to the cloakroom door.</p>	<p>Carpenter</p>
<p>Kitchen Walls</p>

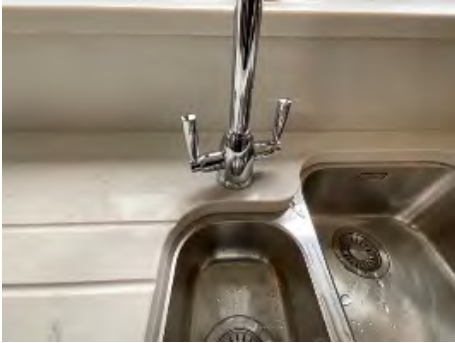
<p>The monobloc mixer tap base is loose and requires tightening.</p>	<p>Plumber</p>
<p>Kitchen Built-In Fittings</p>

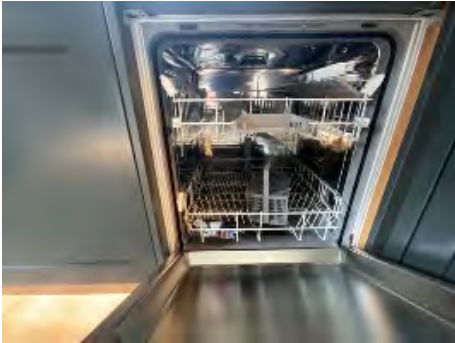
<p>The dishwasher was plugged-in and switched on at the socket however the appliance would not switch-on.</p>	<p>Electrician</p>

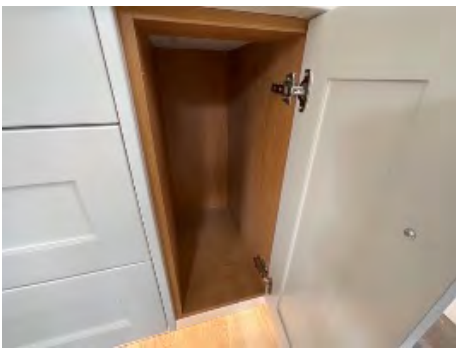
<p>Two cupboards either side of the drawers are missing shelving.</p>	<p>Carpenter</p>
<p>Kitchen Built-In Fittings</p>

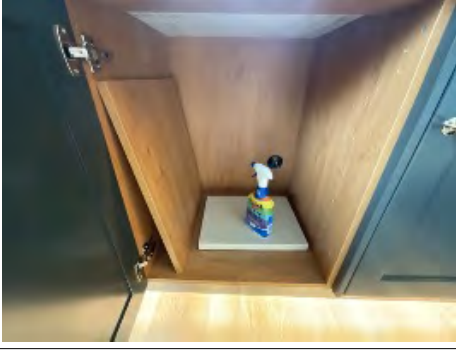
<p>The under sink cupboard requires its shelf to be fitted.</p>	<p>Carpenter</p>
<p>Kitchen Services</p>

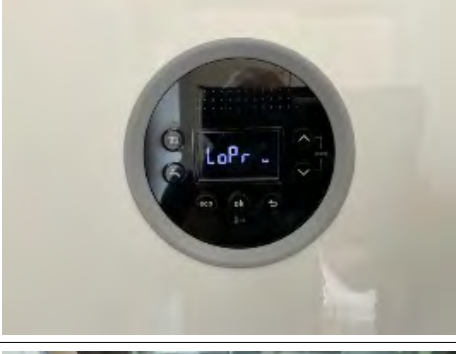
<p>The Worcester Greenstar 8000 GR8300iW condensing combi boiler had low pressure at the time of the inspection and could not be operated.</p>	<p>Plumber</p>
<p>Kitchen Built-In Fittings</p>

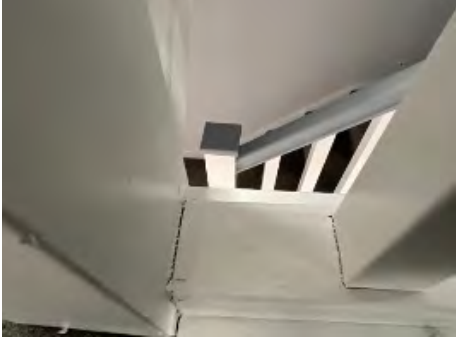
<p>The staircase joinery is sound however shrinkage has cause gaps in joints requiring making good.</p>	<p>Decorator</p>
<p>Landing Joinery</p>

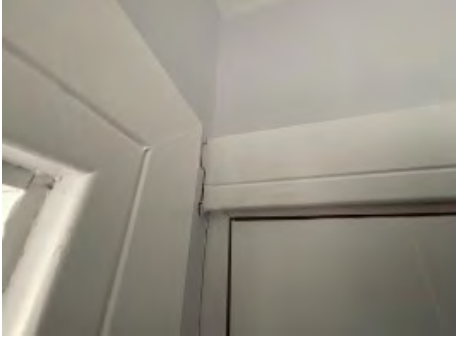
<p>Shrinkage gaps around architraves require caulking.</p>	<p>Decorator</p>

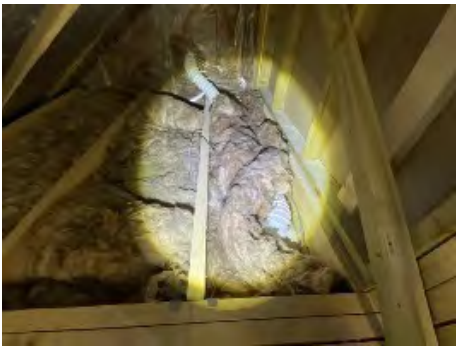
<p>Where disturbed for installing services the insulation has not been uniformly refitted and amounts to approximately 100mm thickness. Recommended depth is 270mm.</p>	<p>General Builder</p>
<p>Other Loft Space</p>

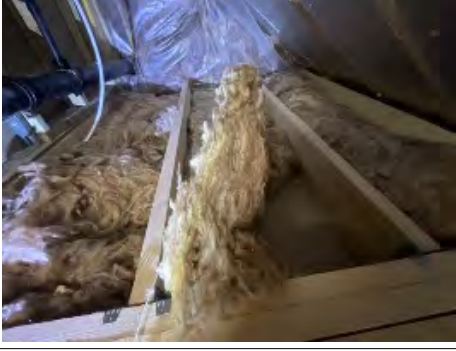
<p>Where disturbed for installing services the insulation has not been uniformly refitted and amounts to approximately 100mm thickness. Recommended depth is 270mm.</p>	<p>General Builder</p>
<p>Other Joinery</p>

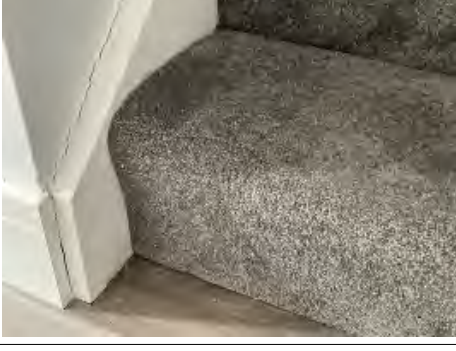
<p>The staircase joinery (the stringers) joint with the wall surface has a gap caused by shrinkage virtually the full length of the staircase which requires caulking.</p>	<p>Decorator</p>
<p>Other Joinery</p>

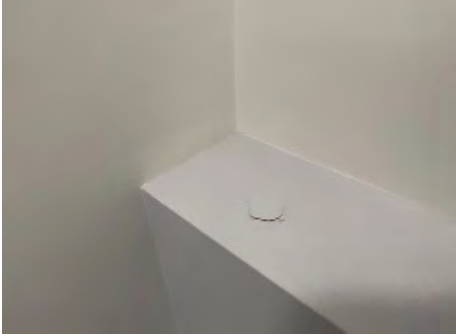
<p>The dry lining to the stairwell has a number of popped screw heads which require making good.</p>	<p>Decorator</p>

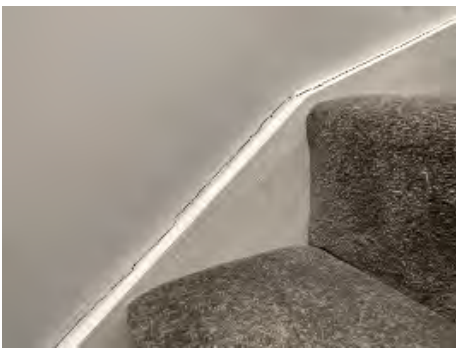
<p>The staircase joinery (the stringers) joint with the wall surface has a gap caused by shrinkage virtually the full length of the staircase which requires caulking.</p>	<p>Decorator</p>
<p>Other Walls</p>

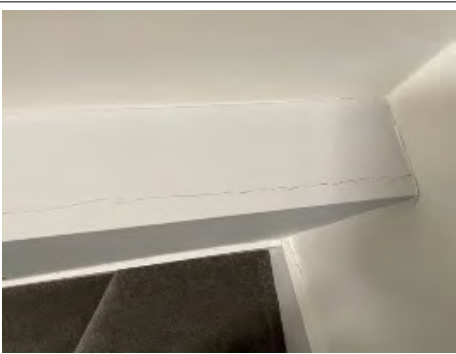
<p>The dry lining to the stairwell has a number of shrinkage cracks along the line of the board edges that require making good.</p>	<p>Decorator</p>
<p>Reception 1 Built-In Fittings</p>

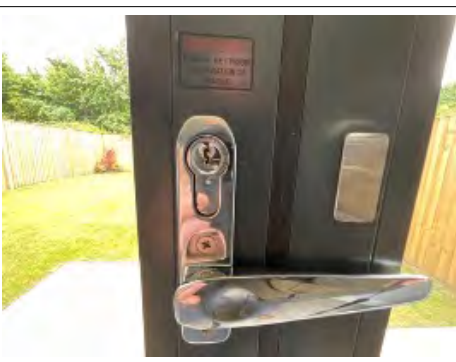
<p>The bi-fold doors could not be opened. There is a snapped key. The key may have snapped in the in the lock.</p>	<p>Other</p>
<p>Reception 1 Services</p>

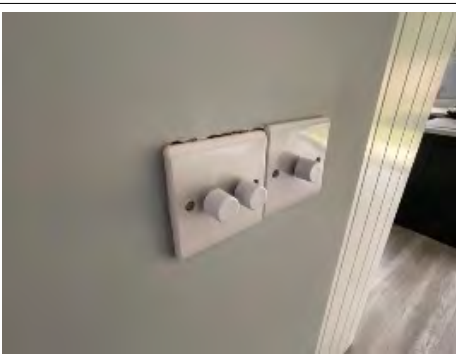
<p>The dimmer switches in the lounge are loose which also gives an untidy finish to the surrounding decoration.</p>	<p>Electrician</p>

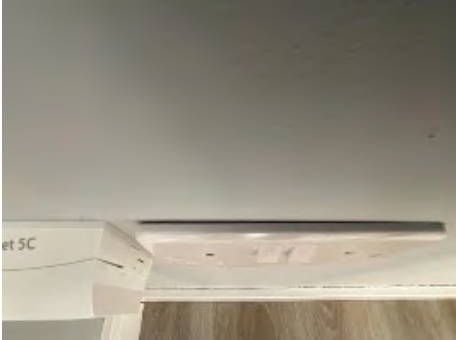
<p>The socket on the front wall is loose.</p>	<p>Electrician</p>
<p>Reception 1 Walls</p>

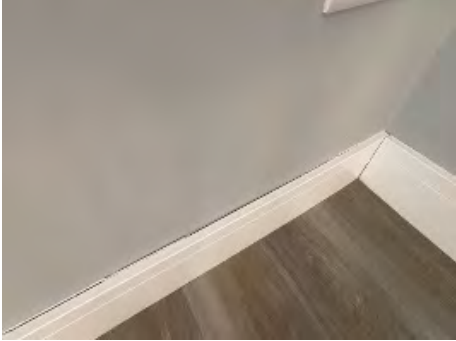
<p>There is a gap between the skirting and the wall due to shrinkage which requires caulking.</p>	<p>Decorator</p>
<p>Reception 1 Joinery</p>

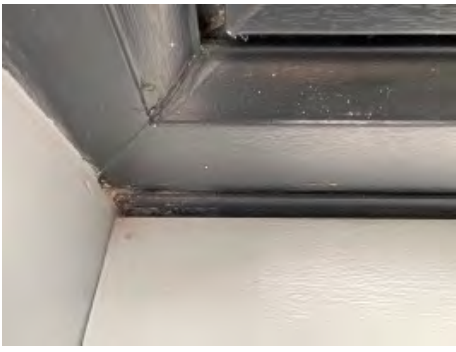
<p>The gap between the window frame and the cill.</p>	<p>Carpenter</p>
<p>Reception 1 Walls</p>

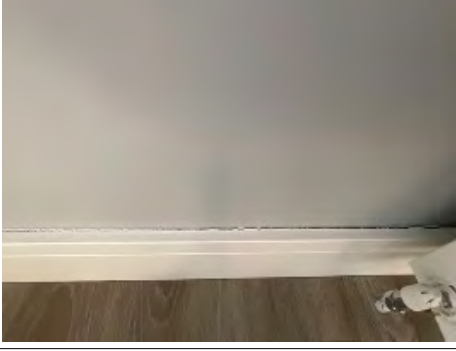
<p>The gap between the wall and the skirting requires caulking.</p>	<p>Decorator</p>
<p>Reception 1 Walls</p>

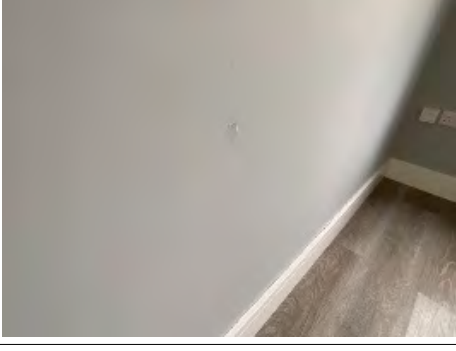
<p>There are numerous popped screw heads in the dry lining requiring remedial work.</p>	<p>Decorator</p>
<p>Reception 1 Ceilings</p>

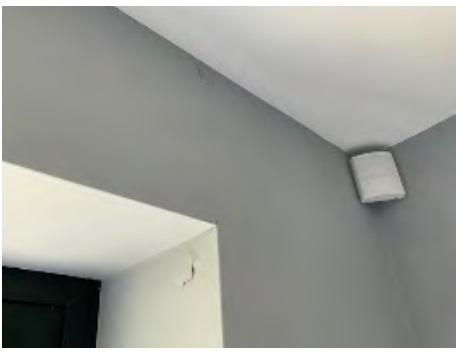
<p>There are numerous popped screw heads in the dry lining requiring remedial work.</p>	<p>Decorator</p>
<p>Reception 3 Joinery</p>

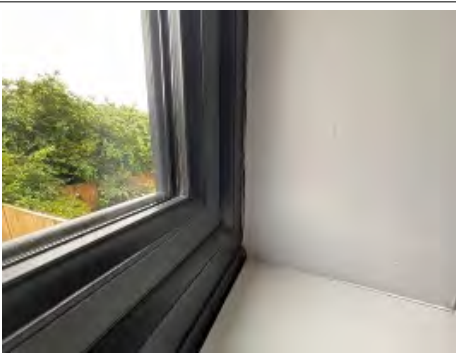
<p>Popped screw heads in dry lining in the reveal.</p>	<p>Decorator</p>
<p>Utility Room Walls</p>

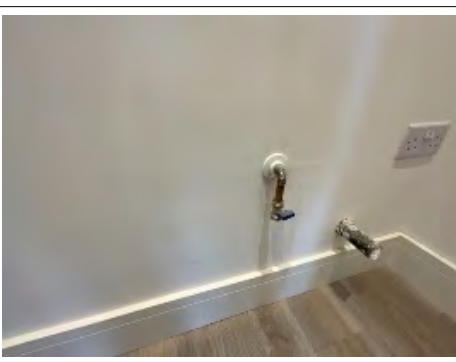
<p>Painted surface marked and scuffed. Requires touching up.</p>	<p>Decorator</p>
<p>Utility Room Ceilings</p>

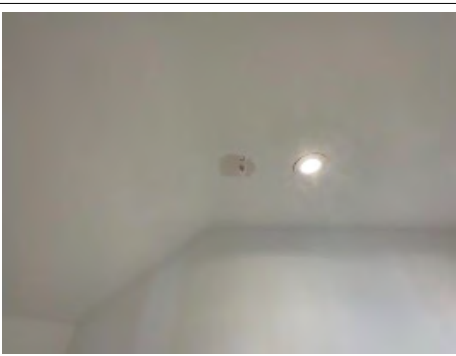
<p>A repaired patch on the utility cupboard ceiling requires finishing.</p>	<p>Decorator</p>
