# BUILDING SURVEY REPORT

**PROPERTY** Sample Survey  
Anytown  
AA11 1AA

**SURVEY DATE** 2 Jan 2018

**REF** 12345

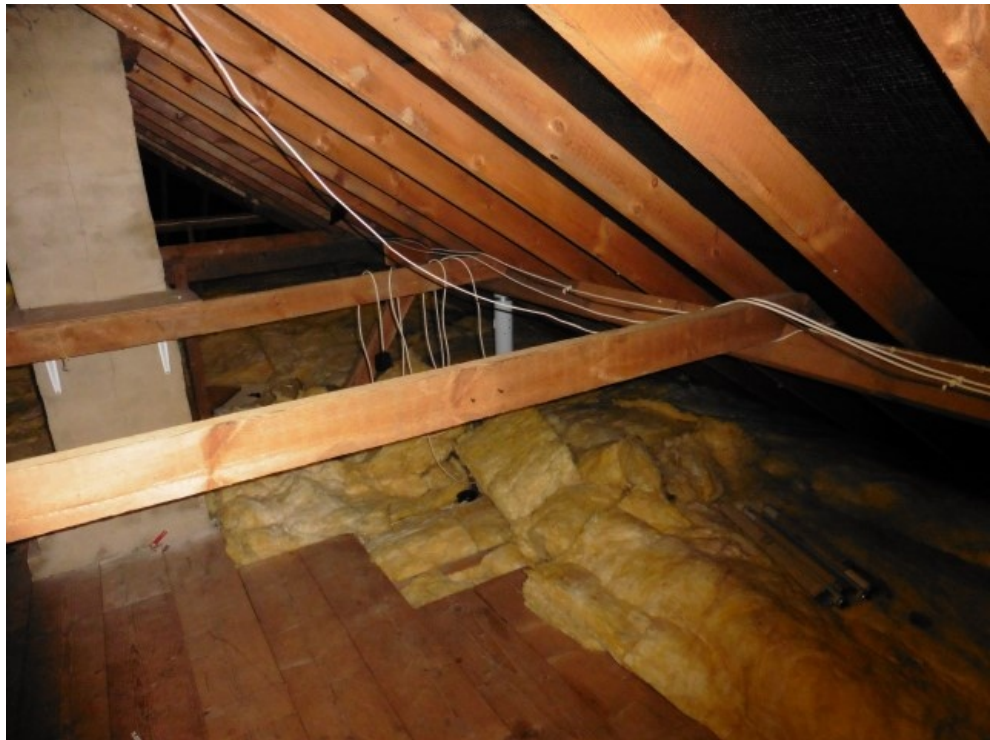
<b>5.1 Roof Spaces</b>	<b>Condition rating</b>	<b>1</b>
<b>Construction &amp; Type</b>	The bulk of the rear space has been converted into living accommodation. Copies of plans seen at the time of the survey suggest that this conversion work was carried out in 1976/7. Part of the conversion included provision of some storage cupboards within the eaves, both to the front and the back, and within these cupboards hatches lead to the edges of the eaves. In both cases, though, stored possessions prevented any direct access, however as far as can be seen, no parts of the roof structure are visible, with all areas being covered by panelling or other materials.		
<b>Nature of inspection and Limitations</b>	The roof space was examined for signs of bowing, twisting, cracking and failure of roof timbers, signs of failure or damage to the roof covering, infestation including birds, ..... .....		
<b>Condition</b>	No significant defects were noted during my inspection and the roof was found to be structurally sound. No evidence was seen of any unusual movement or stress of the supporting timbers within the roof, and there have been no obvious significant alterations to the structure which might have resulted in it becoming substantially weakened.  The roof space is laid with 200-300mm of ..... .....  High moisture levels within roof spaces are responsible for the promotion of the development of timber defects such as rot and infestations by wood boring insects (commonly known as woodworm). Wood moisture content readings taken were found to be well within normal limits and below the levels normally required for this type of defect.

Looking towards the right

<b>Action Required</b>	Although no evidence of active infestations of wood boring insects was identified, it is important to remain vigilant and be aware that such infestations can become active after long periods of inactivity.

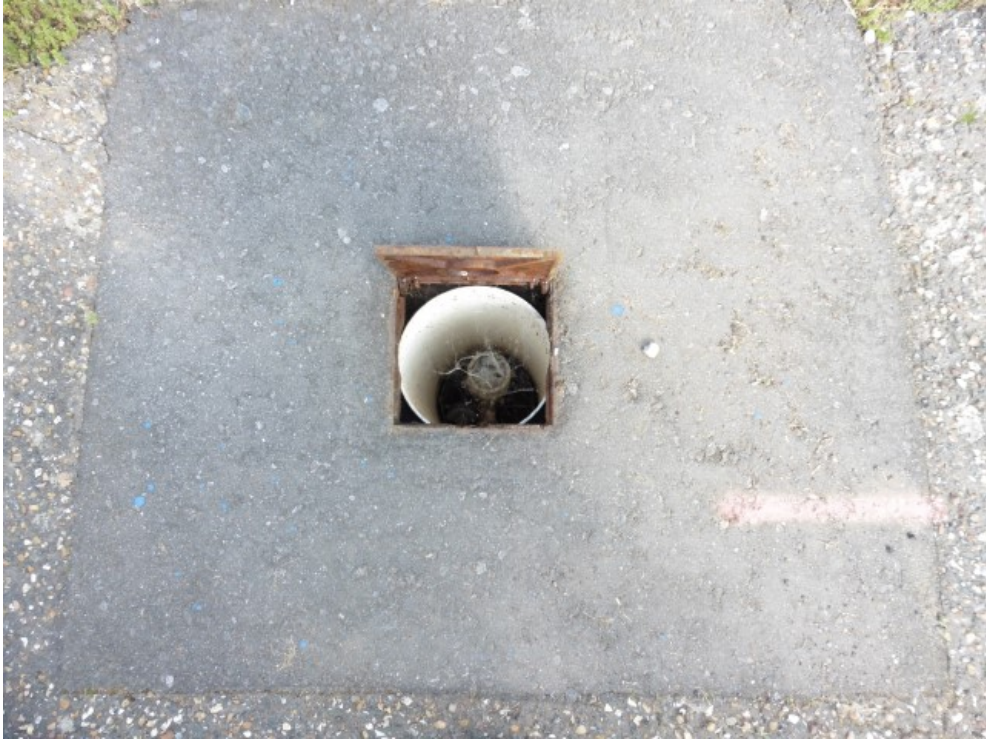
<b>6.3 Water</b>	<b>Condition rating</b>	<b>1</b>
<b>Construction &amp; Type</b>	<p>There is a mains water supply. The visible pipework is copper and the internal stop valve is in the the boiler cupboard in the bathroom</p> <p>The supply to the property includes a water meter which is located under a flap in the footpath at the front.</p> <p>As the property is fitted with a combination boiler there are no hot or cold water tanks used with the system.</p>		
<b>Nature of inspection and Limitations</b>	<p>The installation was inspected for any obvious signs of damage or leakage.</p>		
<b>Condition</b>	<p>No significant defects were noted.</p>		
<b>Action Required</b>	<p>Check the installation for evidence of leaks or other defects on a regular basis i.e. approximately every 6 months, or sooner. Leaks most often occur at pipe joints and where pipes are subject to movement or physical damage, such as airing cupboards, roof spaces and under sinks.</p>

</div> <p style="text-align: center;">Location of water meter</p>

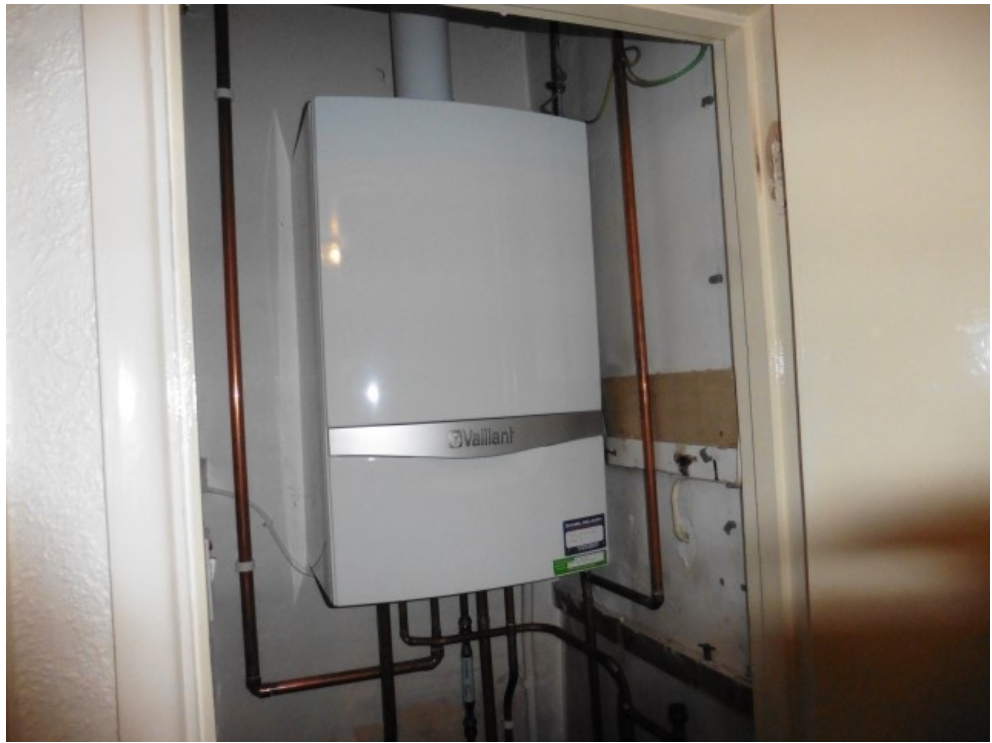
Boiler

<b>6.4 Heating and Cooling</b>	<b>Condition rating</b>	<b>HS</b>
<b>Construction &amp; Type</b>	<p>The heating and hot water is provided by a gas-fired condensing combination boiler which is located in a cupboard in the bathroom.</p> <p>The boiler is a Glow-worm Ultracom 30 cxi. On the SEDBUK seasonal efficiency database this boiler is shown as having a SAP 2009 annual efficiency rating of 88.5%. It is believed that this model was first manufactured in 2007. It is understood that the boiler was fitted in 2009.</p> <p>Heating is distributed by radiators in most rooms.</p> <p>The heating is controlled by a programmer located on the boiler, a wall thermostat in the ground floor hall and thermostatic valves on some radiators.</p>		
<b>Nature of inspection and Limitations</b>	<p>At the time of the survey the heating was checked and the boiler appeared to fire up normally. The operation of any heating controls such as thermostats could not be checked.</p> <p>It is not possible to fully assess the condition and safety of a gas installation on the basis of a visual inspection only. A visual inspection was carried out of the radiators, pipework and boiler to detect leaks, corrosion and other common defects.</p>

<b>Condition</b>	<p>Documentary evidence was seen to indicate that the boiler was serviced in December 2015 and that checks confirm that the contractor is Gas Safe registered. The seller indicated that the boiler had been installed in 2009. This means that it is approximately eight years old and, therefore, around half way through its normal expected service life, subject to regular maintenance.</p> <p>At the time of the survey the heating was checked and the boiler .....</p>		
<b>Action Required</b>	<p>Gas Safe recommends that all gas appliances and boilers are inspected and serviced according to manufacturer's guidance, but at least once a year. A gas installation can look to be in a safe condition, but serious defects may be hidden, some of which can kill. It is therefore considered to be essential that you commission an inspection of the gas/heating installation prior to purchase of the property, unless you are provided with verifiable evidence that such an inspection has recently been carried out by a competent person.</p>

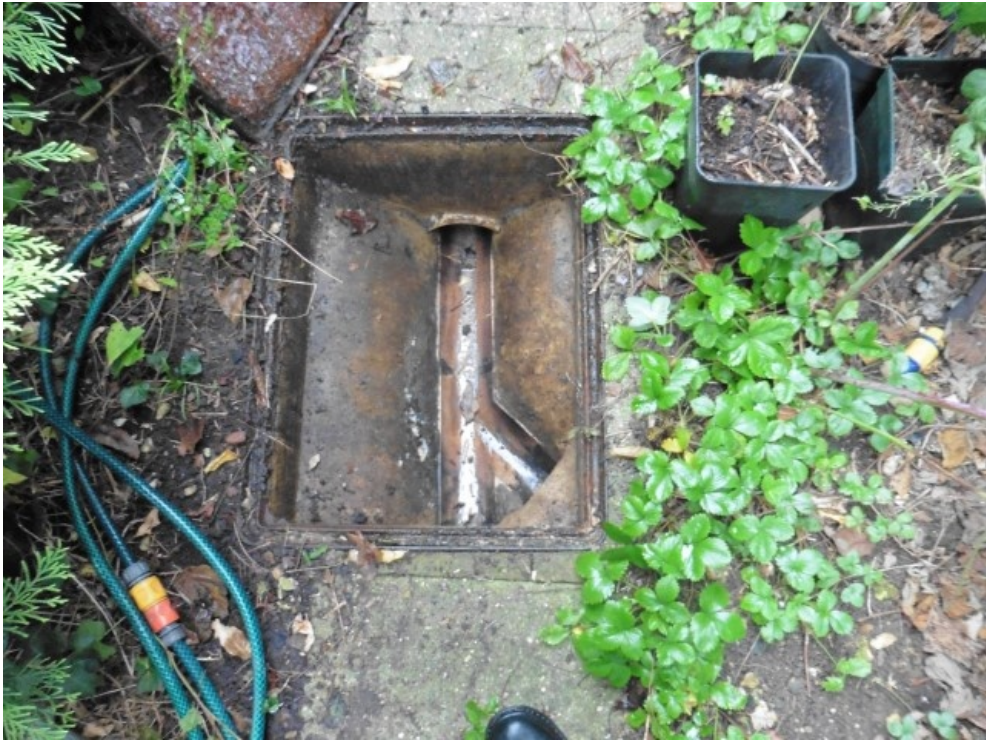
<b>6.5 Drainage</b>	<b>Condition rating</b>	<b>1</b>
<b>Construction &amp; Type</b>	<p>The property is understood to be connected to mains drainage. Your conveyancer should confirm this to be the case and advise the water authority to whom fees are payable in respect of sewerage.</p> <p>Two drainage inspection chambers were identified at the property, one to the rear and one to the front</p>		
<b>Nature of inspection and Limitations</b>	<p>The lids of both inspection chambers were lifted, all taps were run and WC's flushed, and water was observed running through the chambers.</p> <p>It should be noted that the underground drainage network was not inspected with the use of cameras and therefore no assessment could be made of the condition of the drains other than at the inspection chambers described above.</p>		
<b>Condition</b>	<p>From the inspection carried out it is apparent that waste water is firstly directed to the rear the property whereupon it is directed under the right side path, through the chamber at the front, and from there into the main sewer road.</p> <p>Toilet flush and tap water was seen to run through the drains without any apparent blockages, and the rate of flow suggests that there is sufficient fall on the drains to reduce the risks of blockages.</p>

</div> <p style="text-align: center;">Inspection chamber to the rear</p>

<b>Action Required</b>	<p>Drains should be regularly inspected to ensure they remain free from blockages, tree root damage or other obstructions.</p>		
	<div style="text-align: center;">

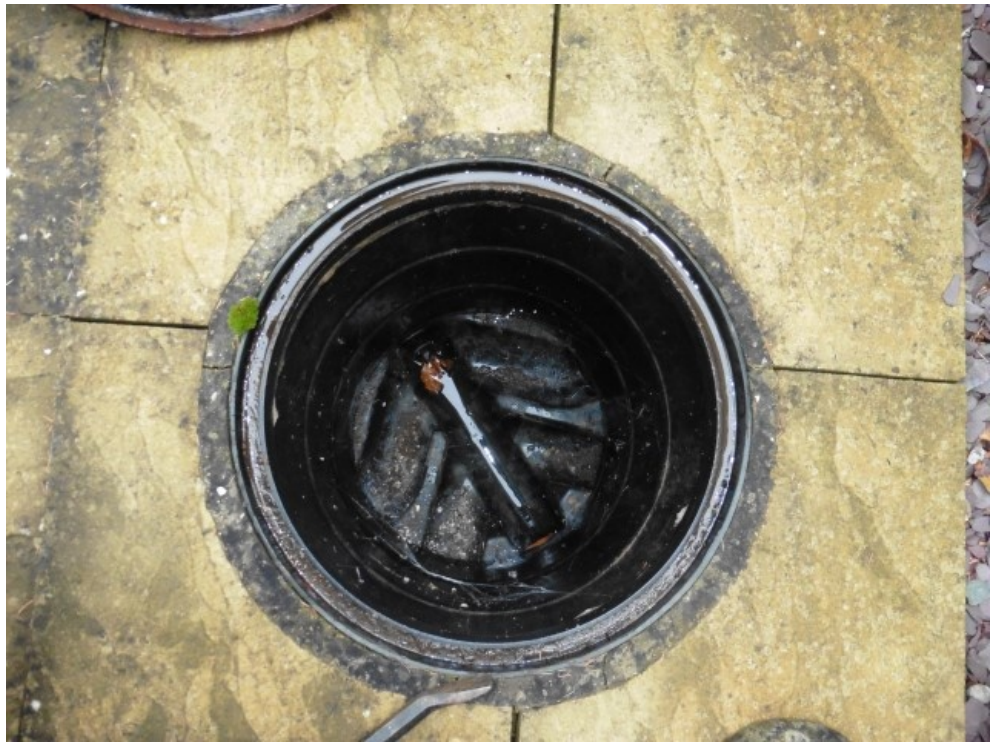
Inspection chamber to the front

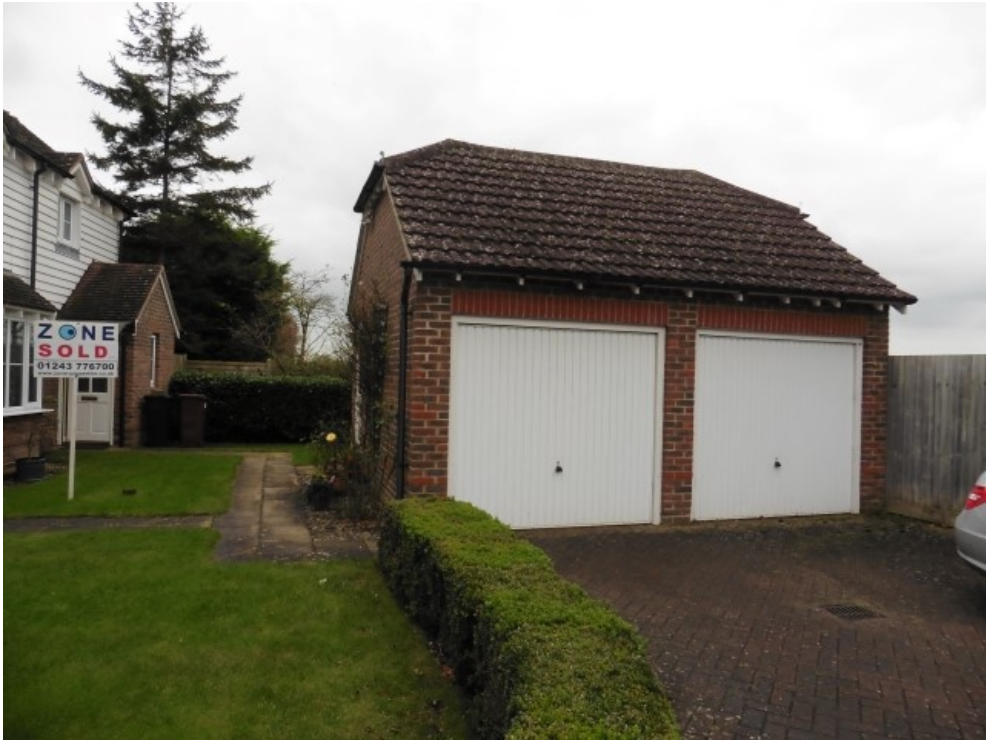
<b>Condition</b>	<p>The garage was found to be in a stable condition with no evidence of any cracking of the walls of floor which might indicate that it is subject to unusual structural movement such as subsidence or settlement.</p> <p>The roof covering is in a good condition without any undue numbers of slipped or missing tiles.</p> <p>All of the doors were found to operate normally.</p>		
<b>Action Required</b>	<p>Normal maintenance, including regular retreatment of external joinery, is required.</p> <p>Foliage and debris should be removed from the outside walls.</p>		
	<div style="text-align: center;">

<p>Garage</p> </div>

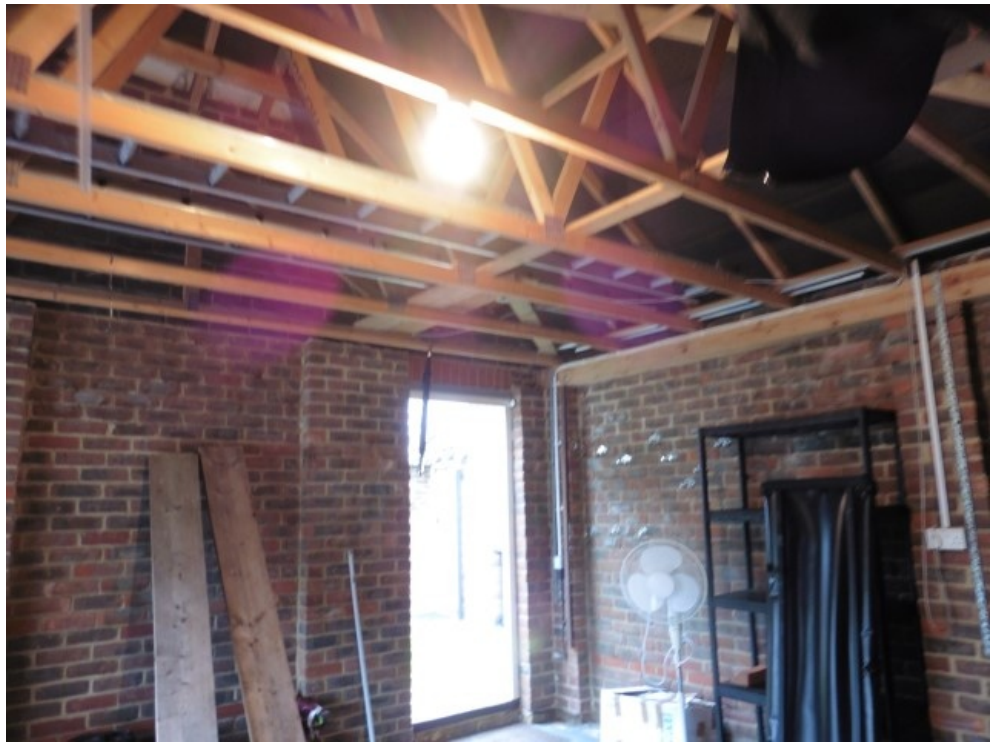
Garage internal review
