SURVEY DATE 1 Sep 2018

BUY-TO-LET SURVEY REPORT

INCLUDING CONDITION and HEALTH & SAFETY REVIEW

REF 2788

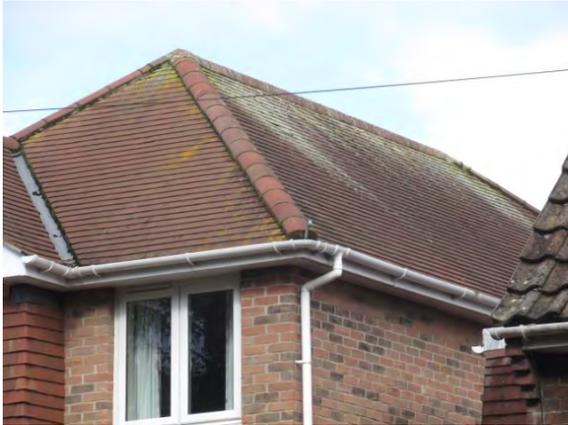
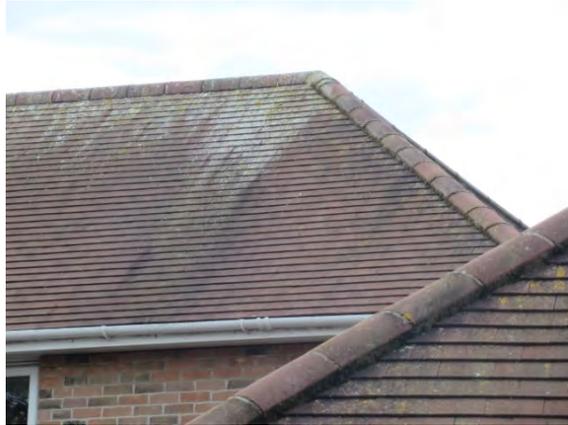
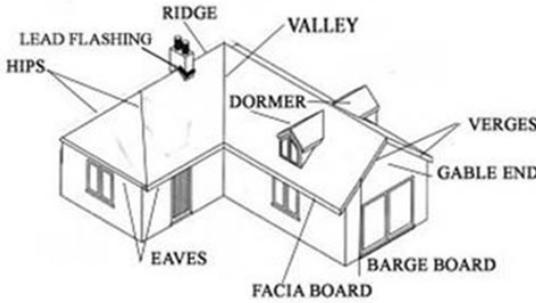
Condition	<p>No significant defects were noted and the roof was found to be structurally stable. No evidence was seen of unusual sagging or other movement which might indicate that the structure is failing.</p> <p>There are no significant numbers of slipped, missing or broken tiles visible on the roof pitches. Some moss growth was evident and this should be cleared as a matter of routine maintenance to prevent over-weighting the roof structure.</p> <p>The lead flashing that seals the polycarbonate roof of the rear living room extension has become dislodged to the right side and has been secured with tape. If not properly seated this will leak and so the flashing should be removed and reset. This may require complete replacement of the flashing. Although this is not major work, it should be carried out as soon as possible after occupation, and preferably before the next winter.</p> <p>Carry out normal maintenance including removal of moss build-up.</p> <p>Any slipped, missing or broken tiles on the roof pitches should be repaired and replaced.</p> <p>You should carry out a thorough visual inspection at least once a year, ideally in the Spring to identify and repair any damage that could have been caused by winter weather.</p> <p>Polycarbonate roofs, such as that to the rear, have a limited lifespan of, perhaps 10-20 years, and will require regular replacement.</p>

<p>Front and right side roof pitches</p>	<p>Right side roof pitch</p>
	<p>Loose and taped flashing for the living room extension roof at the back</p>	<p>Roof Elements</p>

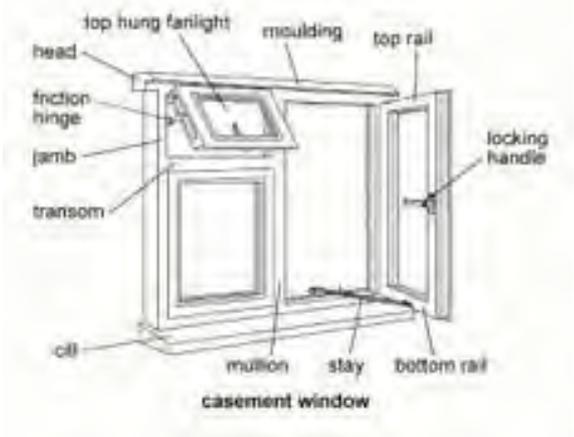
<p>Condition</p>	<p>No significant defects were noted and all of the windows and doors checked were found to operate normally.</p> <p>Under normal circumstances sealed double glazed units can be expected to last between 15-20 years before the seals, locks and hinges begin to fail. This can occur more quickly where windows are in exposed or vulnerable situations.</p> <p>The windows and doors are those installed at the time of construction of the property and so are around 7 years old.</p> <p>Normal maintenance of frames, hinges and locks is required.</p> <p>Be aware that previous owners may have distributed multiple sets of keys for the windows and doors to individuals not known to you. When purchasing a property you should consider the cost of replacing all of the door and window locks as soon as possible after you take up occupation. When doing this you should consult your insurers to ensure that you meet their requirements for security, and obtain any discounts that may be available by improving the security of the property.</p>

<p>Example of casement window style</p>

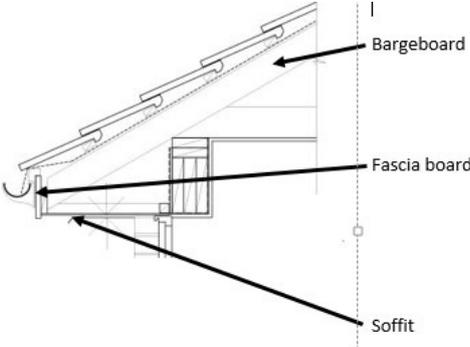
<p>Condition</p>	<p>No significant defects were noted.</p> <p>“Timbers” (including fascias, soffits and bargeboards) at the roof edges are made of uPVC and are in a serviceable condition.</p> <p>Normal maintenance is required which may include replacing dislodged fittings after severe weather.</p>

<p>External joinery detail</p>

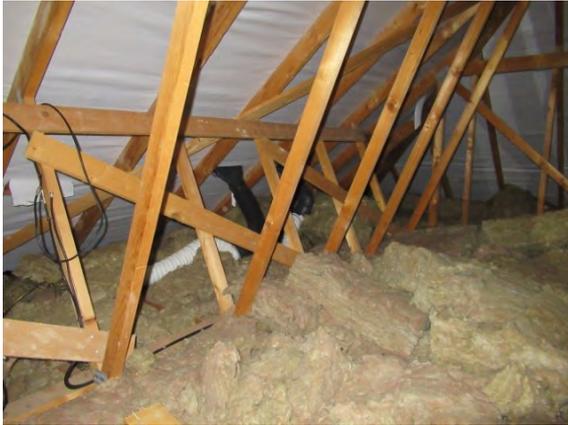
<p>Looking towards the left rear</p>

Condition	<p>No significant defects were noted during my inspection and the roof was found to be structurally sound.</p> <p>No evidence was seen of any unusual movement or stress of the supporting timbers within the roof, and there have been no obvious significant alterations to the structure which might have resulted in it becoming substantially weakened.</p> <p>Trussed rafter roofs are constructed from sections made off-site which are raised into position and fixed during construction of a property. They are constructed from timbers joined by steel plates to a design based on the shape of the roof and the loads imposed by the weight of the roof covering.</p> <p>It is important that the timbers of the roof trusses are not cut, notched or separated as this will significantly weaken the roof structure. They should not be overloaded by storage of heavy objects in the roof space, and the weight of any light items being stored should be well distributed using fixed boards.</p> <p>Between the outer tile covering and the inner timbers is an underlining, sometimes called "sarking". It is present to provide an additional weather-proofing layer to moisture, snow and rain etc. that may be blown past the outer covering. In older properties it may not be present at all. Typically, in the 1920's the sarking is of timber planks. Later properties often have a layer of bituminised felt, while in modern properties a breathable membrane, such as Tyvek, is normally used. In this case the sarking is of a modern breathable membrane. It was found to be in a mostly undamaged condition and is considered to be suitable for its purpose.</p> <p>The roof space is laid with 200-300mm of wool type insulation at joist level. This is close to the current recommendation of 270mm for maximum energy efficiency. It does, however, limit movement and storage within the roof space as any supporting joists are concealed. It is also noted that the insulation is laid quite unevenly and should be redistributed.</p> <p>High moisture levels within roof spaces are responsible for the promotion of the development of timber defects such as rot and infestations by wood boring insects (commonly known as woodworm). Wood moisture content readings taken were found to be well within normal limits and below the levels normally required for this type of defect.</p> <p>No specific repairs are required. However, it is important to ensure that spaces remain well ventilated so as to reduce the likelihood of the development of defects such as rot and infestations by wood boring insects. In many cases, ventilation derives from openings at the eaves at the edge of the roof, though these can become blocked where insulation is forced into the spaces. When adding or replacing insulation, make sure that good ventilation is maintained.</p> <p>If installing extractor fans, make sure that hoses passing through the roof space extend to an external grille so that warm moist air is not ventilated into the roof.</p> <p>Care should be taken when moving around, or storing heavy objects, in the roof space. The spaces between the floor joists will not support a person's weight, or that of large boxes etc. Where heavy items are to be stored it is important to distribute the weight evenly using fixed boards. Additional structural support may be required if you plan to store large quantities of heavy items in the roof space.</p>

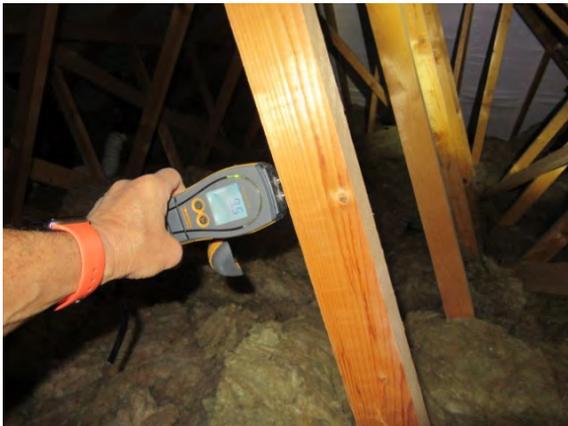
<p>Normal moisture reading</p>

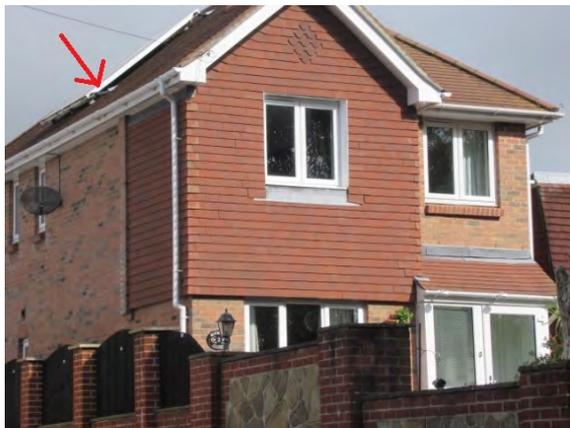
Solar water heating panels on the left side roof pitch

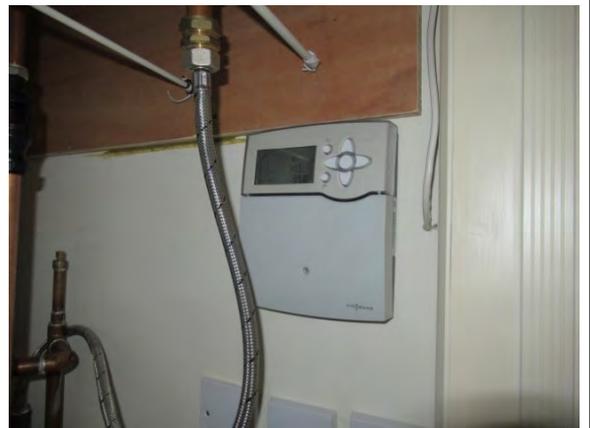
Control panel for the solar water heating panels

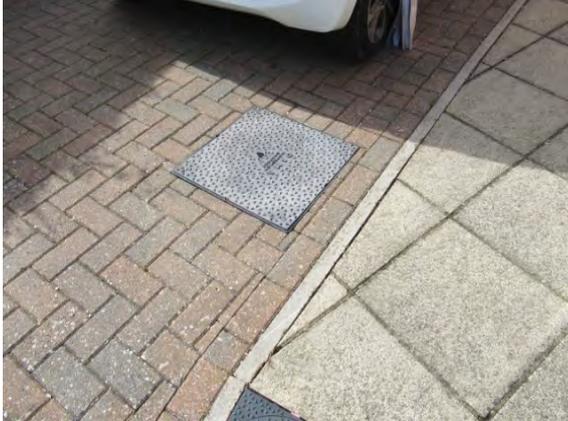
<p>Condition</p>	<p>Water was seen to run through the chamber with no blockages or undue levels of silt being apparent. The direction of flow was from the house, through the chamber in the drive, and out to the road, presumably to a shared sewer.</p> <p>It is often suggested that the manholes only allow inspection of 5-10% of an entire drainage installation. As such, it is entirely possible that damage can be present within the system but which would not be apparent from opening the manholes.</p> <p>The only way to confirm the condition of the whole installation is to commission a CCTV inspection from a qualified contractor, for example a member of the National Association of Drainage Contractors at www.nadc.org.uk/</p> <p>Drains should be regularly inspected to ensure they remain free from blockages, tree root damage or other obstructions.</p>

<p>Inspection chamber in the drive</p>

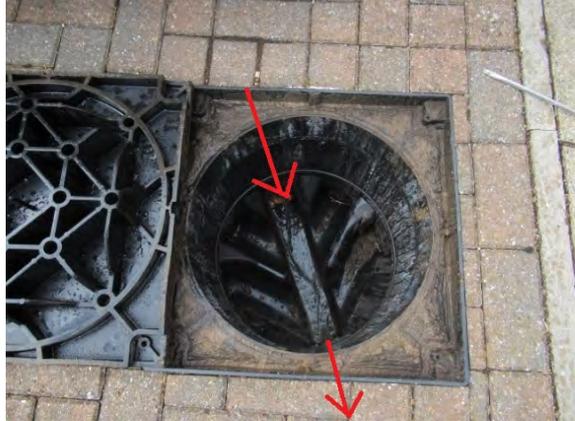
<p>Garage is to top of picture with the flow direction indicated</p>

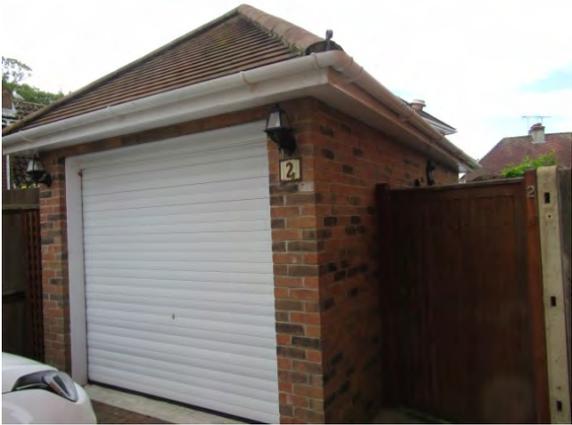
<p style="margin-top: 5px;">Garage</p>

<h3 style="margin: 0;">7.1 Garaging</h3>	Condition rating	1
Construction & Type and Limitations	<p>The detached garage is brick built with a pitched and tiled roof. On the house side is a PVC personnel access door, and to the rear is an electrically operated metal roller shutter door.</p> <p>It was examined from ground level for signs of bowing or leaning of walls, damaged brickwork and pointing, internal defects, and the condition of the roof both internally and externally.</p>		
Condition	<p>The garage is in a stable condition with no evidence of any significant cracking or other unusual movement. Both doors were found to operate normally. Normal maintenance is required.</p>

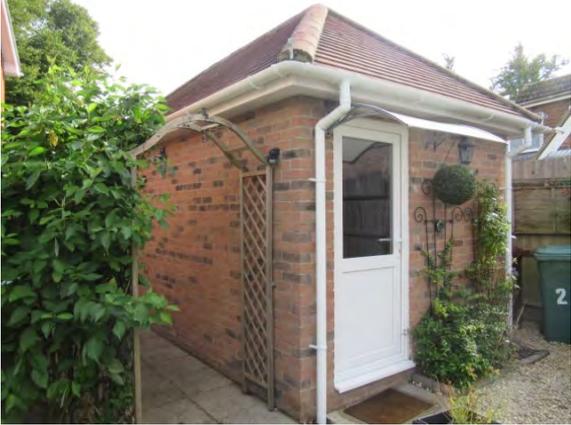
<p style="margin-top: 5px;">Garage view from the house side</p>
