New Build Inspection Report

CLIENT SAMPLE Survey

SURVEY DATE 1 Mar 2023

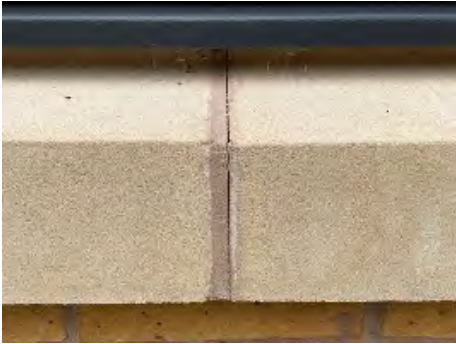
<p>Stone-effect concrete cill requires repointing.</p>	<p>General Builder</p>
<p>Front Elevation</p> <p>Walls</p>

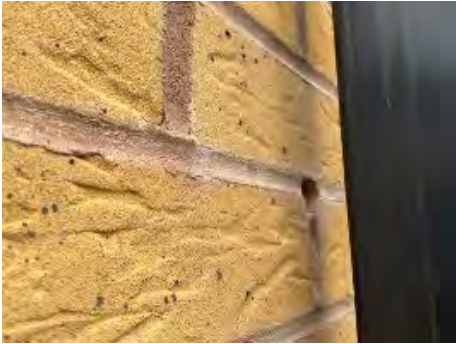
<p>Drill hole behind rainwater pipe on rear elevation on left hand side (looking towards the house from the rear patio).</p>	<p>General Builder</p>
<p>Rear Elevation Walls</p>

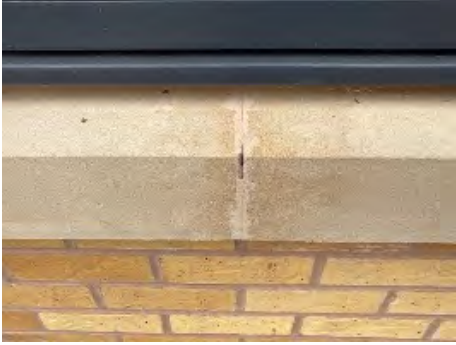
<p>Stone-effect cill requires repointing. Located on rear elevation.</p>	<p>General Builder</p>
<p>Right Elevation Walls</p>

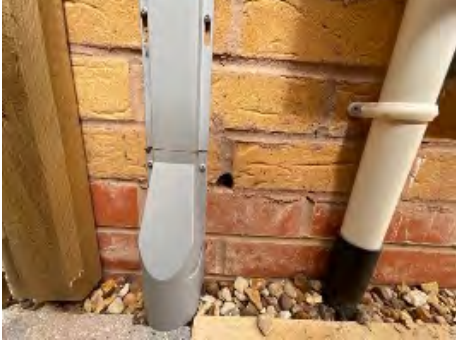
<p>Drill hole through the outer leaf of brickwork to be filled.</p>	<p>General Builder</p>
<p>Right Elevation Walls</p>

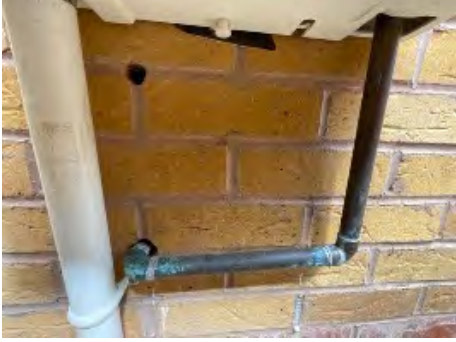
<p>Drill hole through the outer leaf of brickwork to be filled.</p>	<p>General Builder</p>

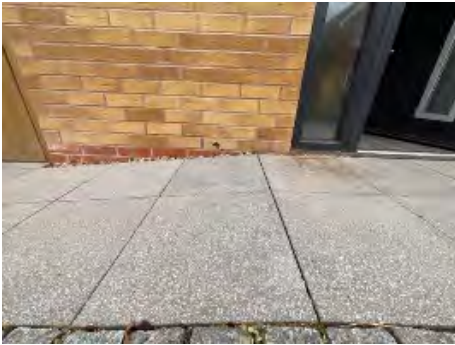
<p>The sloping paved path rises from below the damp proof course to above the damp proof course. The finished ground level is above the damp proof course at the front door.</p>	<p>General Builder</p>
<p>Front of Property</p> <p>General Grounds</p>

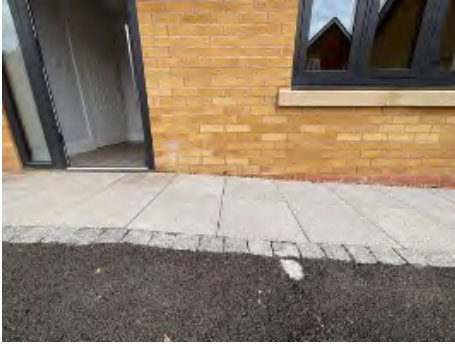
<p>The sloping paved path rises from below the damp proof course to above the damp proof course. The finished ground level is above the damp proof course at the front door.</p>	<p>General Builder</p>
<p>Left of Property</p> <p>General Grounds</p>

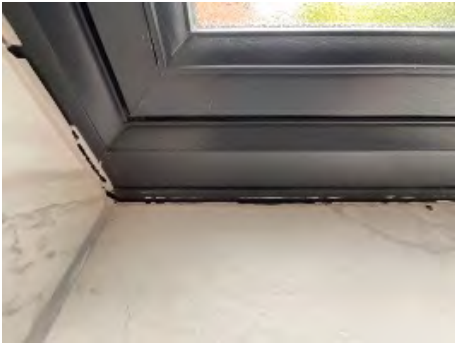
The window frame requires sealing to the tiled sill.	Decorator
Bathroom 1 Built-In Fittings

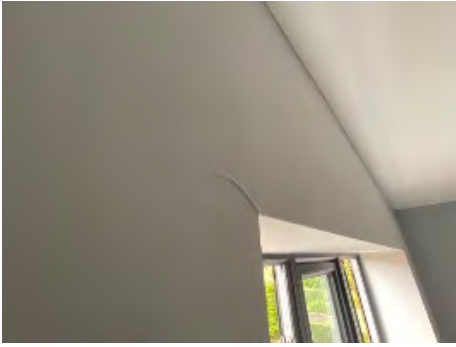
<p>The corner of the reveal requires making good.</p>	<p>Decorator</p>

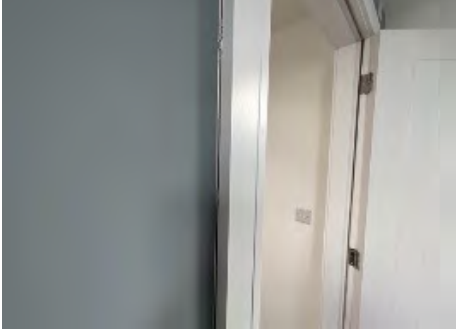
<p>There are shrinkage gaps around the architraves of both doors.</p>	<p>Decorator</p>

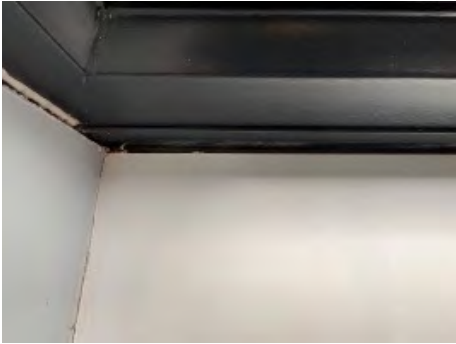
<p>The window frame to cill and surround requires sealing.</p>	<p>Decorator</p>
<p>Bedroom 4 Joinery</p>

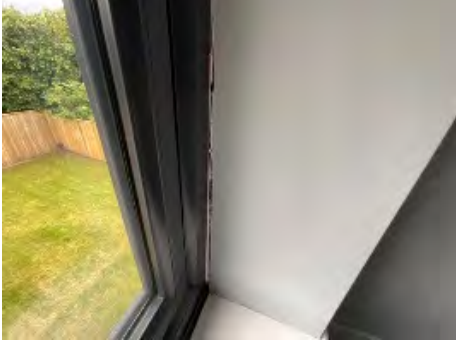
<p>The window frame to cill and surround requires sealing.</p>	<p>Decorator</p>
<p>Bedroom 4 Joinery</p>

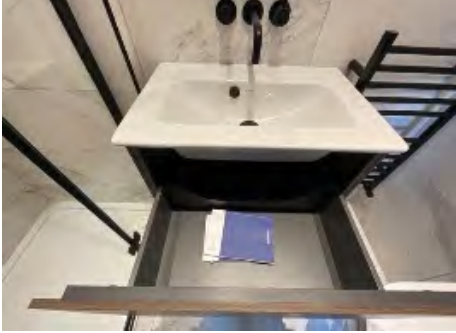
<p>The sliding vanity unit drawer is catching on the sliding mechanism.</p>	<p>Carpenter</p>

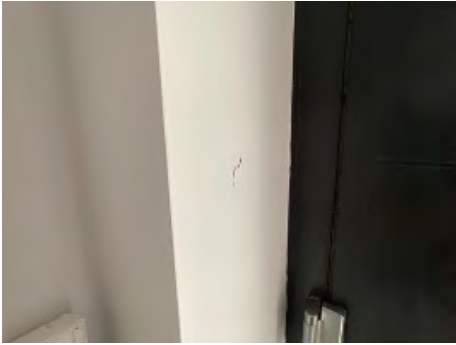
<p>The screws securing the dry lining are popped in numerous places in the hallway.</p>	<p>General Builder</p>

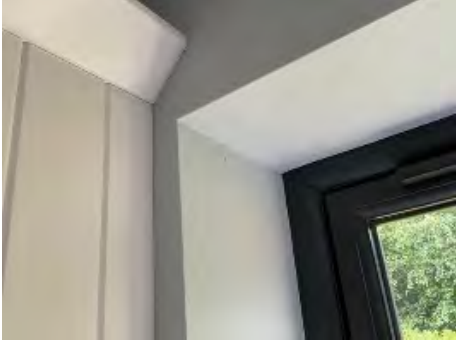
<p>Popped screw heads in the dry lining on the window reveal horizontal and verticals.</p>	<p>Decorator</p>
<p>Kitchen Walls</p>

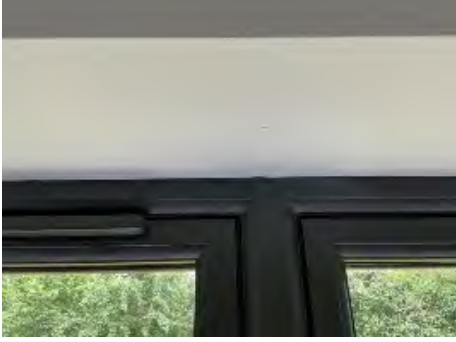
<p>Popped screw heads in the dry lining on the window reveal horizontal and verticals.</p>	<p>Decorator</p>
<p>Kitchen Walls</p>

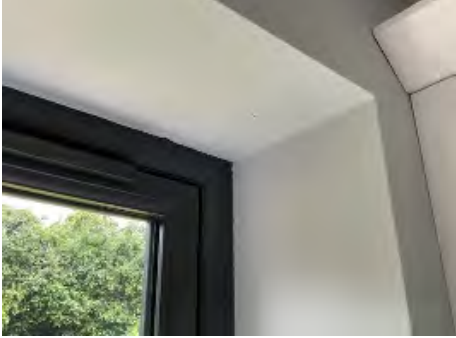
<p>Popped screw heads in the dry lining on the window reveal horizontal and verticals.</p>	<p>Decorator</p>

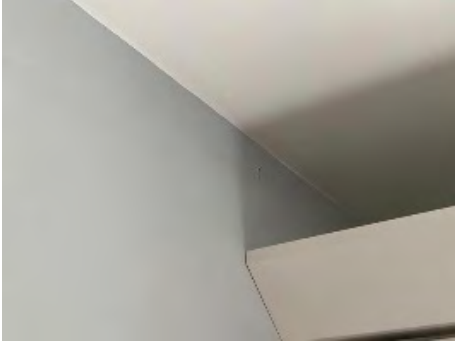
<p>Popped screw heads in the dry lining on the kitchen walls.</p>	<p>Decorator</p>
<p>Kitchen Ceilings</p>

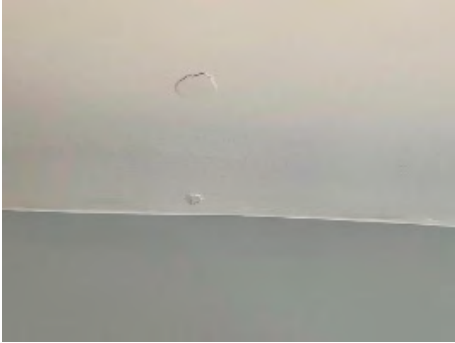
<p>Popped screw heads in the plasterboard ceiling.</p>	<p>Decorator</p>
<p>Kitchen Built-In Fittings</p>

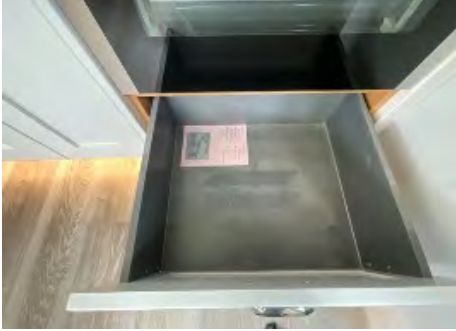
<p>Some of the kitchen cupboards and drawers require a final clean.</p>	<p>Other</p>

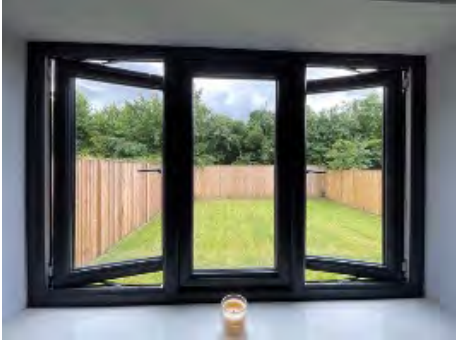
<p>Kitchen Joinery</p>

<p>The kitchen window/window cill have not been sealed at the joints with the cill and the reveal.</p>	<p>Carpenter</p>
<p>Landing Joinery</p>

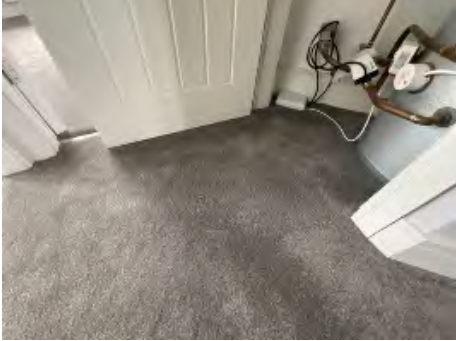
<p>Airing cupboard door requires planing, catching on landing carpet.</p>	<p>Carpenter</p>
<p>Landing Joinery</p>

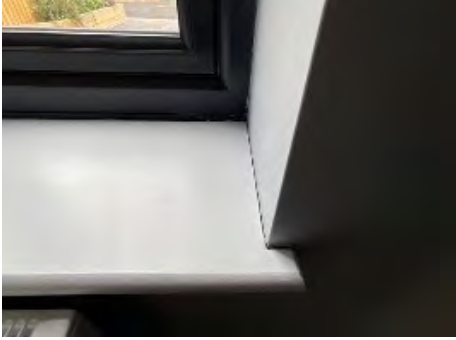
<p>The window cill is not secure and a poor fit and there is no sealant between the cill and the window frame.</p>	<p>Carpenter</p>
<p>Reception 1 Joinery</p>

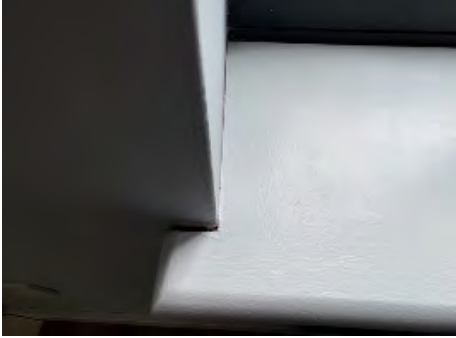
<p>The window cill is not secure and a poor fit and there is no sealant between the cill and the window frame.</p>	<p>Carpenter</p>

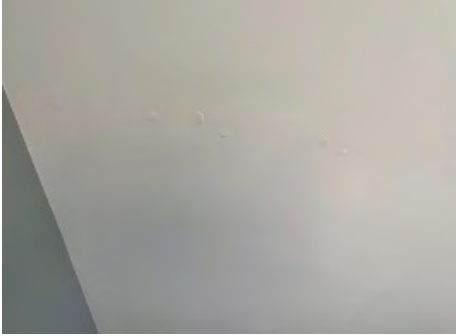
<p>There are popped screw heads in the ceiling plasterboard towards the dining area end of the lounge/diner.</p>	<p>Decorator</p>
